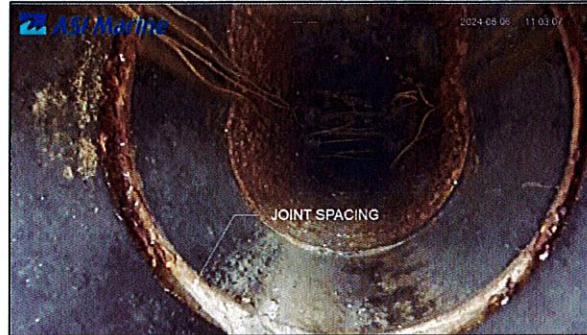
About 3.5 m upstream of the bell mouth, a noticeable joint spacing was observed around the circumference of the pipeline. The joint spacing was approximately 2 cm in longitudinal length.

**Figure 7: Joint spacing**

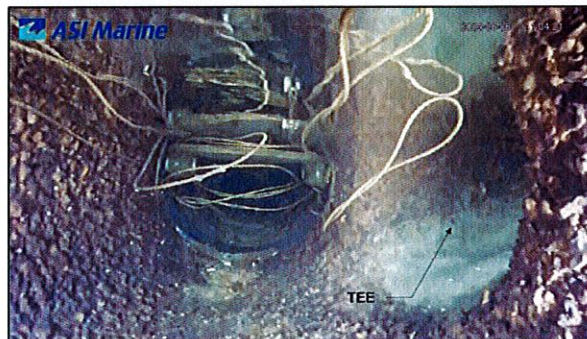
About 4 m upstream of the bell mouth, a tee in the pipe was observed in the 9 o'clock position. At the time of inspection, it was explained by MOK personnel that this tee likely connected to an abandoned intake.

**Figure 8: Tee**

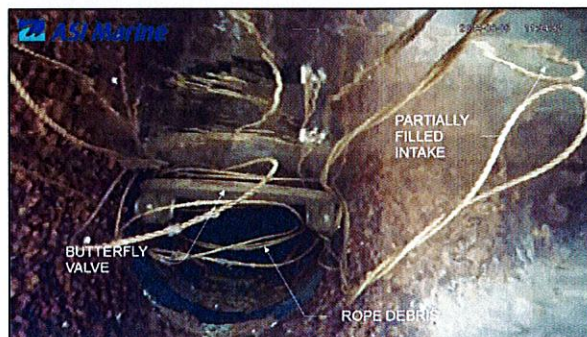
About 4.5 m upstream of the bell mouth, another butterfly valve was observed. The valve was open, and rope debris was observed to be caught in the valve. The pipe was also partially flooded at this location. The ROV was unable to travel any further due to the valve and entanglement hazard.

**Figure 9: Butterfly valve with caught debris**
