Kincardine Municipal Bridge Master Plan – Campbell Bridge (2121)

Municipality of Kincardine

October 28, 2024
Project No. 2402806

Appendix A OSIM Report for Bridge 2121

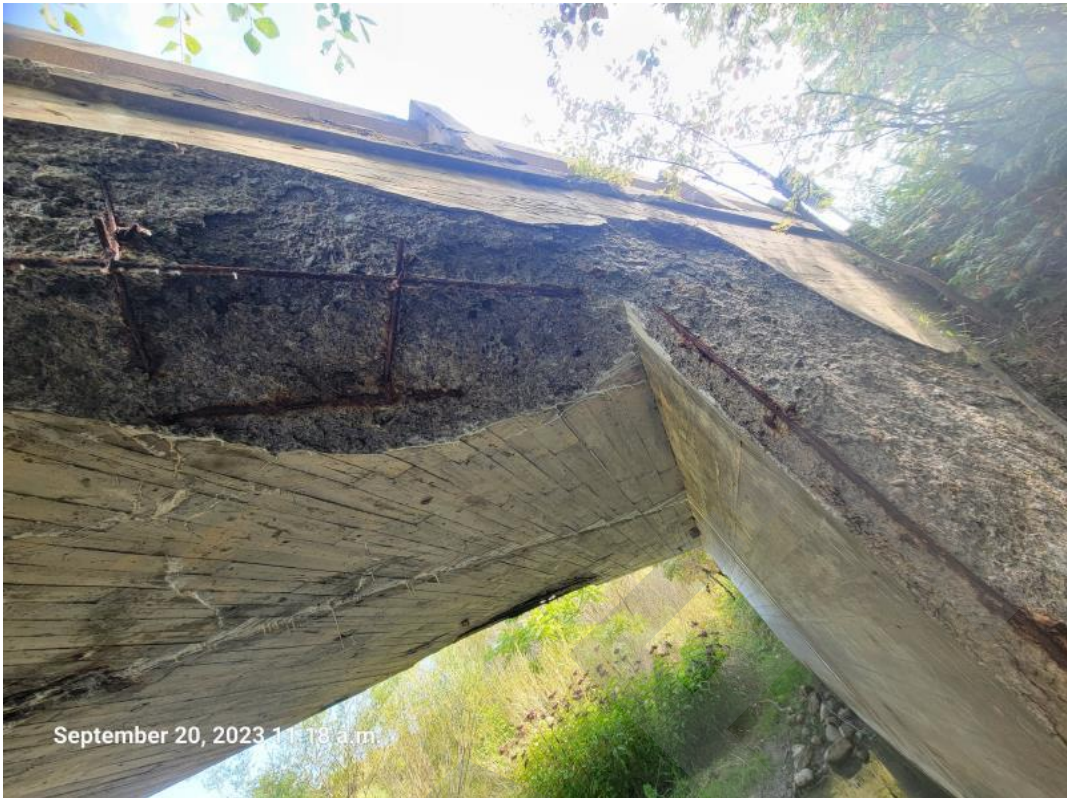
5-Southeast Wingwall and South Deck Edge

Element Type:	Reinforced Concrete			Total Quantity:	37.4 m2	
Environment:	Benign			Limited / Not Inspected:	<input type="checkbox"/>	
Protection System:	None			BCI - Element Condition Values:		
Condition Data:	Excellent	Good	Fair	Poor	TEV	CEV
			40% (14.96)	60% (22.44)	\$13,090	\$2,094
Comments:	Significant spalls at southeast wingwall, full area. Spalling at northwest wingwall as well. Efflorescence staining and delaminations at all corners.					
Performance Deficiencies:						
Recommended Work:	Replace structure.				Recommended Timing:	1-5 years
					Maintenance Priority:	
Maintenance needs:						
Maintenance work:						
Element Data:						
Element Group:	Barriers			Length:	28.35	
Element Name:	Railing Systems			Width:	0.31	
Location:	North/South side			Height:	1.05	
Material:	Cast-in-place Concrete			Count:	2	
Element Type:	Concrete Post and Continuous Railing			Total Quantity:	56.7 m	
Environment:	Severe			Limited / Not Inspected:	<input type="checkbox"/>

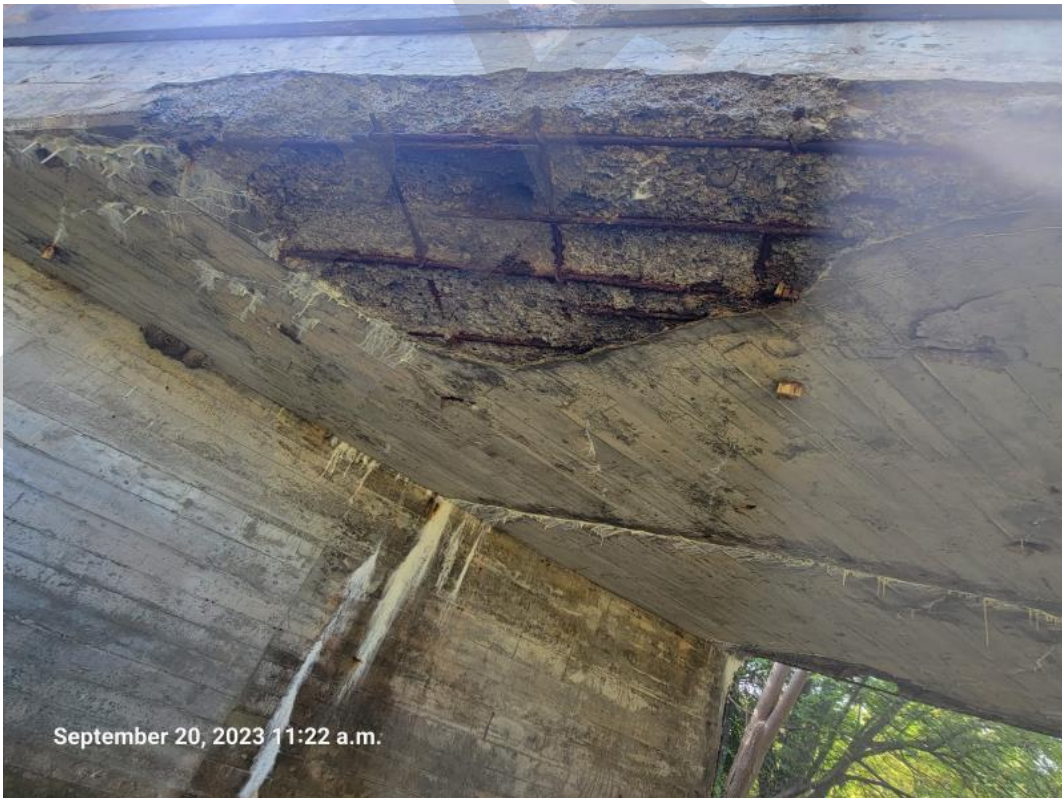
8-Soffit at Northeast Drain

Environment:	Moderate			Limited / Not Inspected:	<input type="checkbox"/>	
Protection System:				BCI - Element Condition Values:		
Condition Data:	Excellent	Good	Fair	Poor	TEV	CEV
				100% (4)	\$0	\$0
Comments:	Badly corroded, too short causing deck deterioration.					
Performance Deficiencies:						
Recommended Work:	Replace structure.				Recommended Timing:	1-5 years
					Maintenance Priority:	
Maintenance needs:						
Maintenance work:						
Element Data:						
Element Group:	Decks			Length:	15.24	
Element Name:	Soffit - Thick Slab			Width:	6.3	
Location:				Height:		
Material:	Cast-in-place Concrete			Count:	1	
Element Type:				Total Quantity:	96 m2	
Environment:	Benign			Limited / Not Inspected:	<input type="checkbox"/>	
Protection System:	None			BCI - Element Condition Values:		
Condition Data:	Excellent	Good	Fair	Poor	TEV	CEV
			40% (38.4)	60% (57.6)	\$33,600	\$5,376
Comments:	Significant spalls and deterioration at drain locations and centreline.

Performance Deficiencies:						
Recommended Work:	Replace structure.				Recommended Timing:	1-5 years
					Maintenance Priority:	
Maintenance needs:						
Maintenance work:

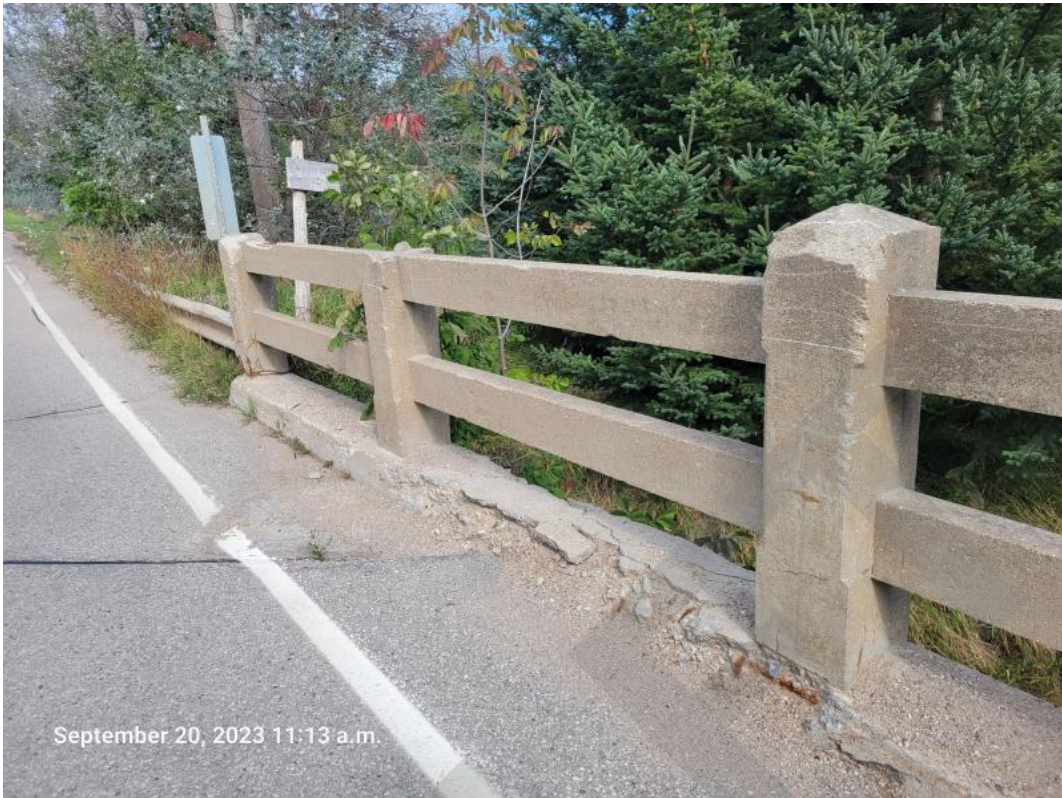
Northwest Railing End

Protection System:	None			BCI - Element Condition Values:		
Condition Data:	Excellent	Good	Fair	Poor	TEV	CEV
				100% (56.7)	\$11,340	\$0
Comments:	Top of 7 posts are broken and the rebar is exposed and concrete badly cracked at two locations. 1 post and 2 rail sections replaced at southeast corner, vertical crack in new bottom rail and spalling in new post. Not to current standards.					
Performance Deficiencies:						
Recommended Work:	Replace structure.				Recommended Timing:	1-5 years
					Maintenance Priority:	
Maintenance needs:						
Maintenance work:
