MUNICIPALITY OF KINCARDINE

Building and Stairway Condition Assessments

Council Meeting
March 26, 2025

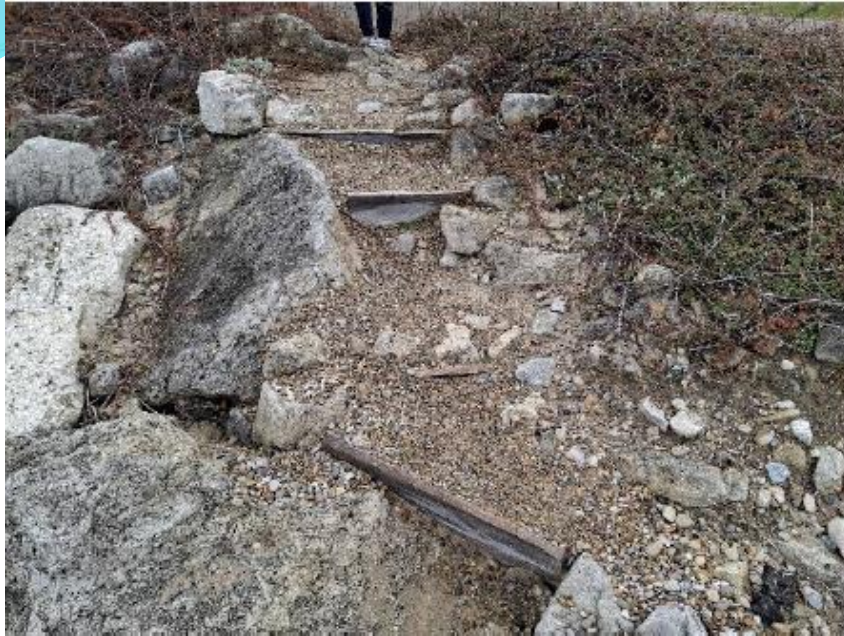
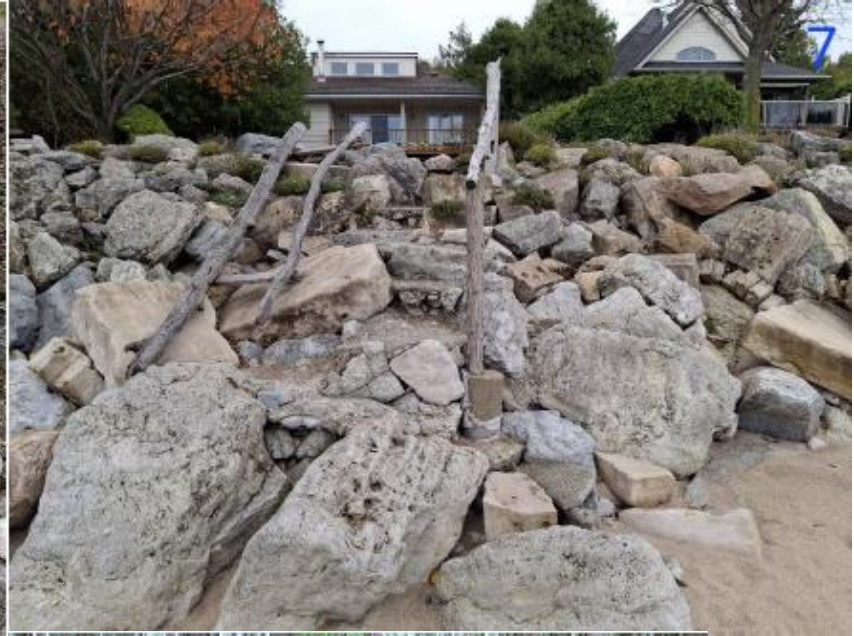
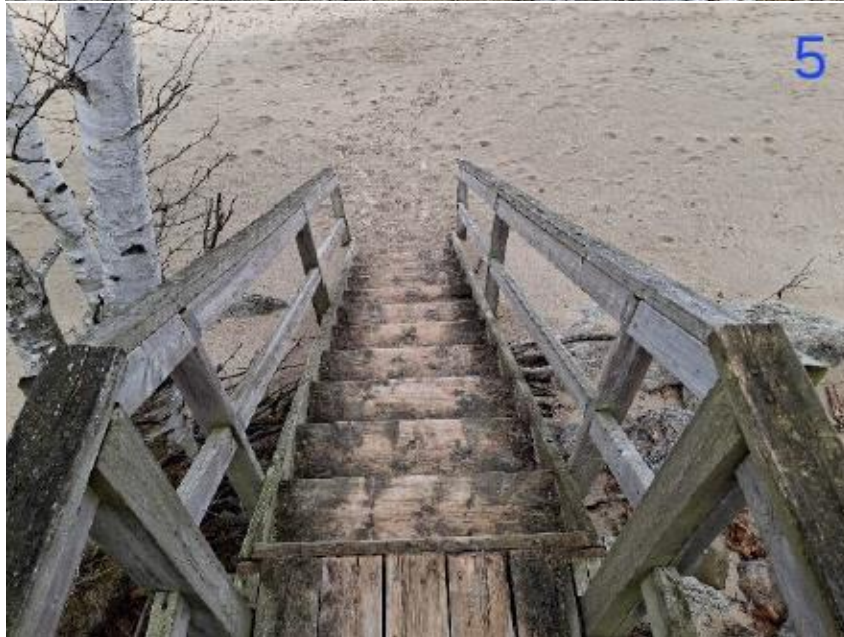
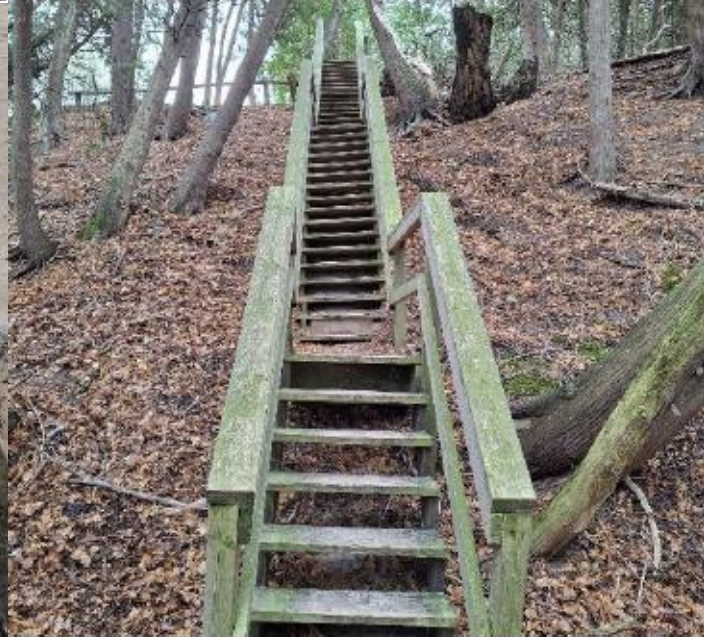
Stairway Images

- None of the stairs have slip resistant treads, risers are not closed in, no tactile plate at the top of each stairway, no colour contrasting nosing, handrails are not suitable shape or size or configured as per the codes.
- In addition, the pathways approaching the stairs often do not comply with the standards for a Recreational Trail.
- Many of these do not look like a stairway but appear as a access pathway with concrete or stones places as steps and no handrail or a flimsy handrail on one side.

- Some structural repairs were recommended in the reports to address safety concerns.
- With some stairways we have recommended replacement. However, since some stairs are in close together; we would recommend installing one good set of stairs in that location and signage directing pedestrians to use the new stairway.
- With some locations, we described them as an access pathway instead of a stairway. When upgrading these should be made in compliance with the Beach Access or Recreational Trail standards.
