Kincardine Municipal Bridge Master Plan

Municipality of Kincardine

February 12, 2025
Project No. 2402806

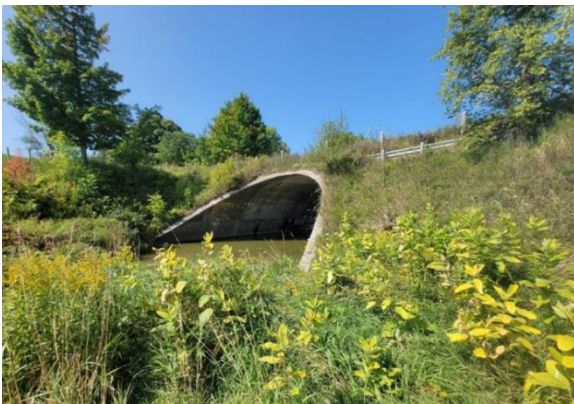
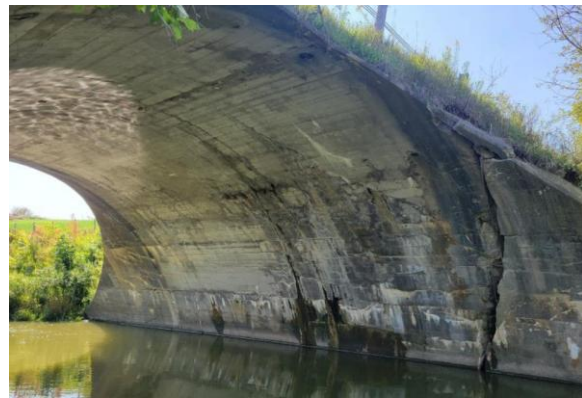
6.1.1. Bridge 2128

Bridge 2128 was evaluated for the screening criteria, with key details summarized in **Table 6-1**, to a total score of 100/100 and rank of 1. Through the OSIM report, this bridge was recommended for replacement which will cost the Municipality \$3,592,000.

This is the highest short-term score, with high repair costs and low traffic volumes. A short detour length with high posted speed limits also contributes to the high score and makes **retirement** financially beneficial to the Municipality.

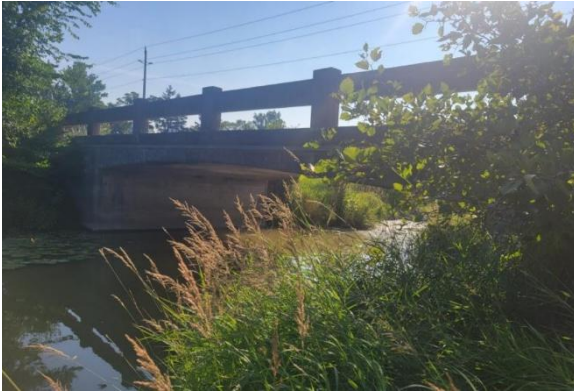
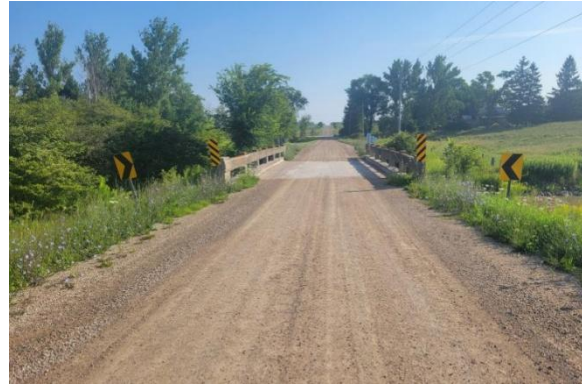
6.1.2. Bridge 2610

Bridge 2610 was evaluated for the screening criteria, with key details summarized in **Table 6-3**, to a total score of 93/100. This score is tied for second in the rankings for short-term retirement with Bridge 2136. Through the OSIM report repairs are recommended for this bridge which will cost the Municipality \$519,000.

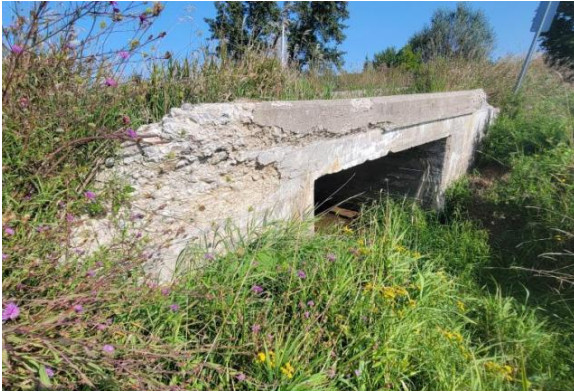
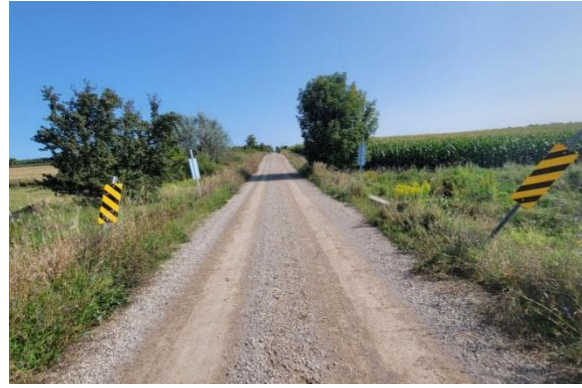
6.1.3. Bridge 2136

Bridge 2136 was evaluated for the screening criteria, details summarized in **Table 6-5**, to a total score of 93/100, tied for rank 2 with Bridge 2610. Located on Side Road 5 between Concession 11 and Bruce Road 15, BM Ross recommended that this structure be replaced in the next 5 years. This work would cost the Municipality \$562,000.

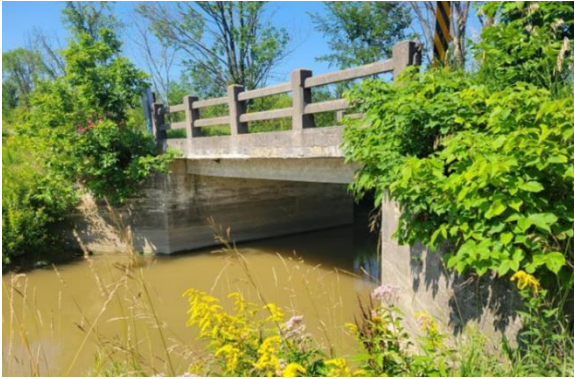
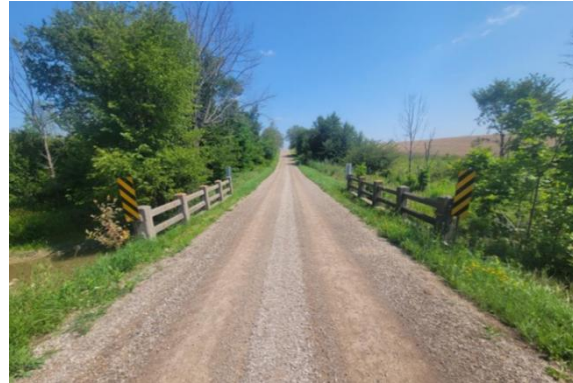
6.1.4. Bridge 2621

Bridge 2621 was evaluated with the screening criteria for a total score of 87, as summarized in **Table 6-7**, surpassing the threshold for retirement. Located on Side Road 15 this structure is in poor condition and requires \$216,000 repairs.

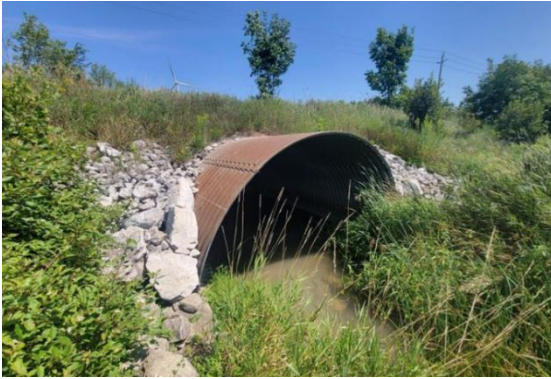
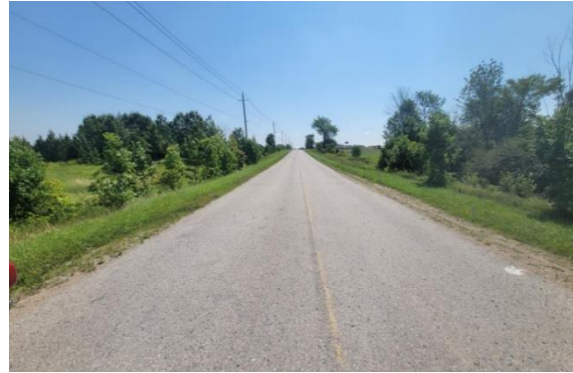
6.1.5. Bridge 2624

Bridge 2624 was evaluated for the screening criteria, with key details summarized in **Table 6-9**, to a total score of 87/100. Through the OSIM report this bridge was recommended for replacement which will cost the Municipality \$816,000.

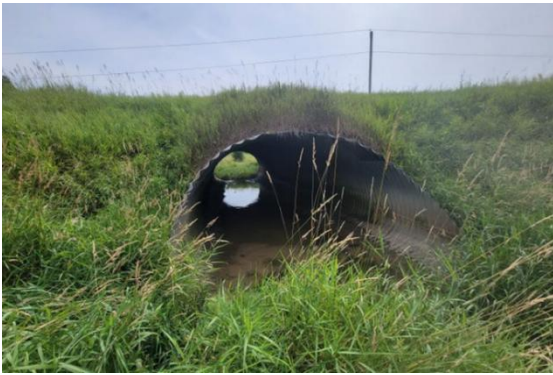
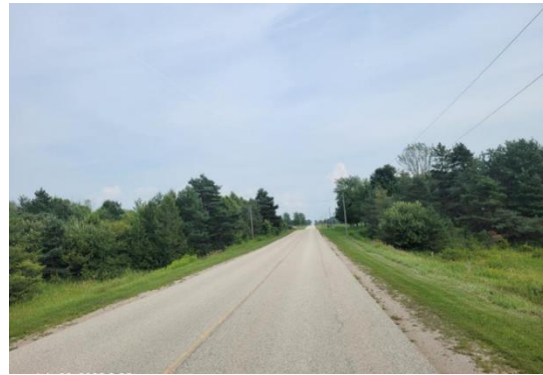
6.1.6. Bridge 2630

Bridge 2624 was evaluated for the screening criteria, with key details summarized in **Table 6-11**, to a total score of 87/100. Through the OSIM report, this bridge was recommended for replacement which will cost the Municipality \$508,500.

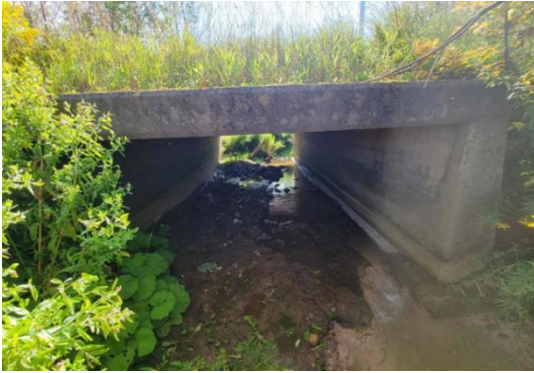
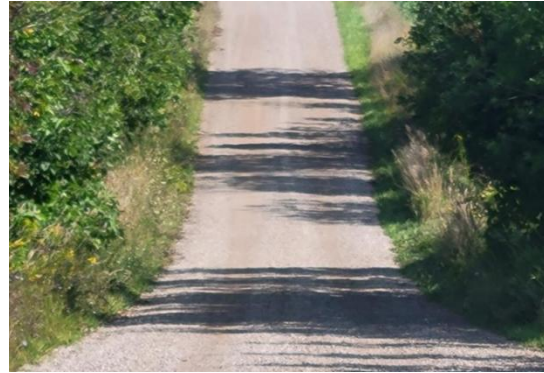
6.1.7. Bridge 2134

Bridge 2134 was evaluated for the screening criteria, with key details summarized in **Table 6-13**, to a total score of 87/100. Through the OSIM report, this bridge has repairs which will cost the Municipality \$159,000.

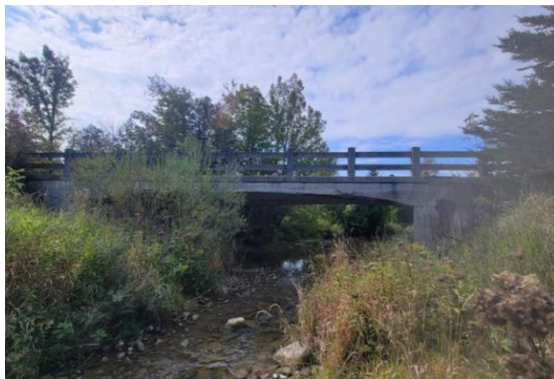
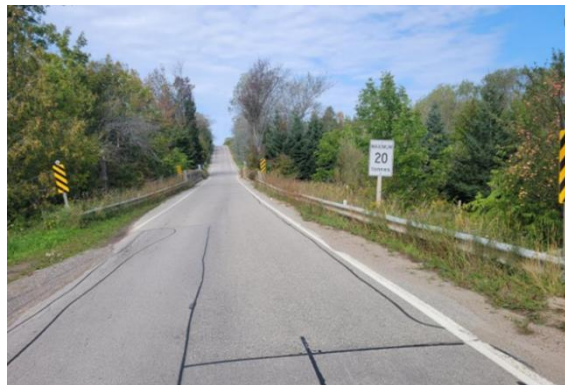
6.1.8. Bridge 2121

Bridge 2121 was evaluated for the screening criteria, with key details summarized in **Table 6-15**, to a total score of 67/100. This is not a high score due to the higher volume of traffic seen on this bridge noting that the bridge is on the route to the Armow Waste Management Center, contributing to the higher AADT.

It should be noted that Bridge 2121 did not meet the threshold criteria for screening primarily due to its higher traffic counts; however, as its repair is one of the costliest at \$3,927,000, in the short term (<10 years), additional detailed evaluations were performed to confirm preferred action.

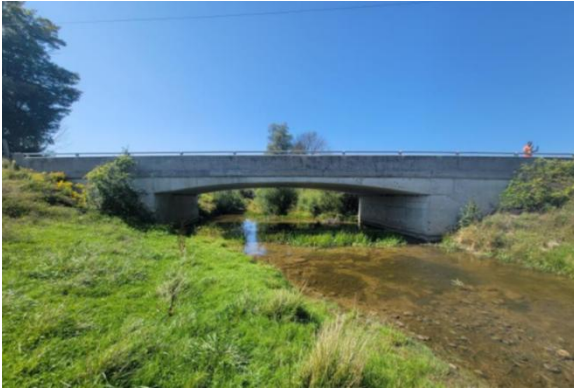
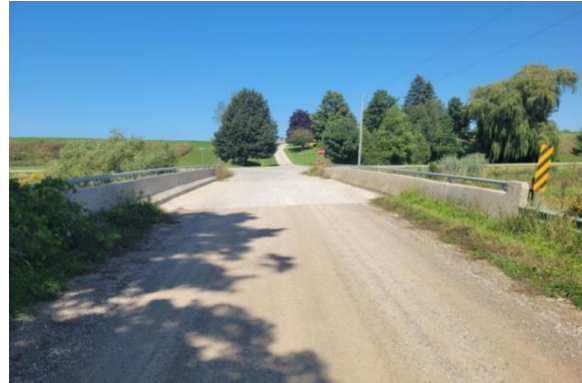
6.2.1. Bridge 2101

Bridge 2101 was evaluated for the long-term screening criteria, with details summarized in **Table 6-17**, to a total score of 74/100. The replacement, as per the CRV, would cost the Municipality \$1,567,500.

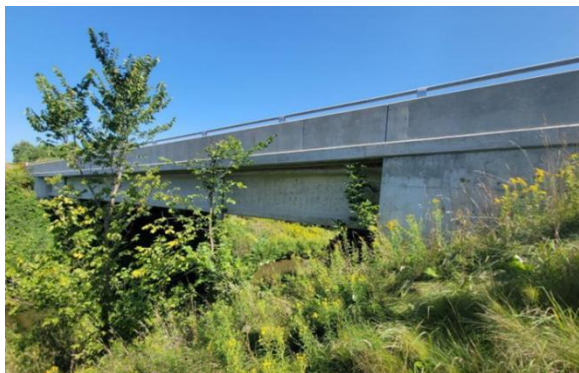
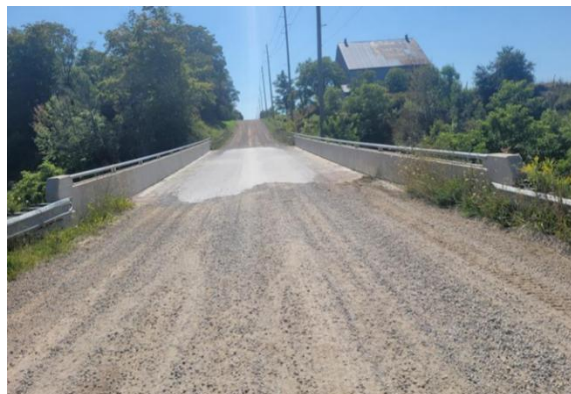
6.2.2. Bridge 2102

Bridge 2102 was evaluated for the long-term screening criteria, with details summarized in **Table 6-19**, to a total score of 74/100. The replacement, as per the CRV, would cost the Municipality \$2,603,500.

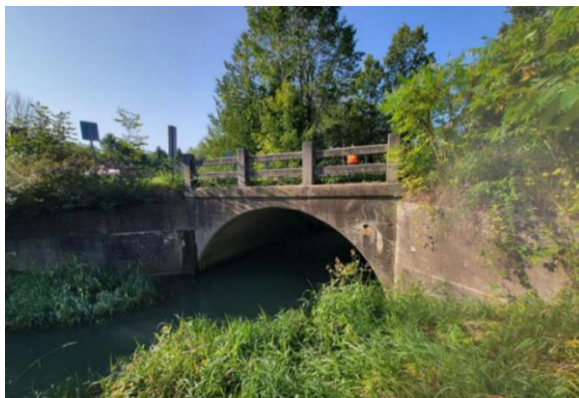
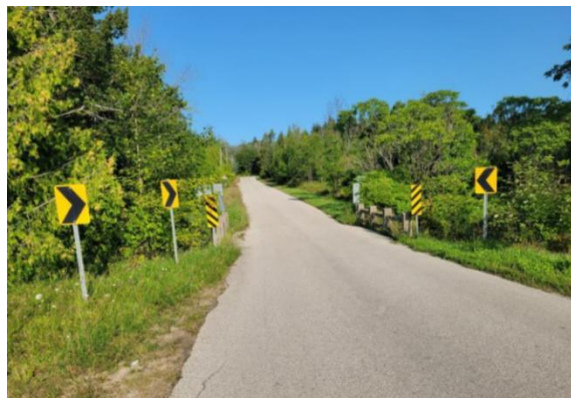
6.2.3. Bridge 2602

Bridge 2602 was evaluated for long-term retirement, scoring 74/100, summarized in **Table 6-21**. The replacement, as per the CRV, would cost the Municipality \$387,600.

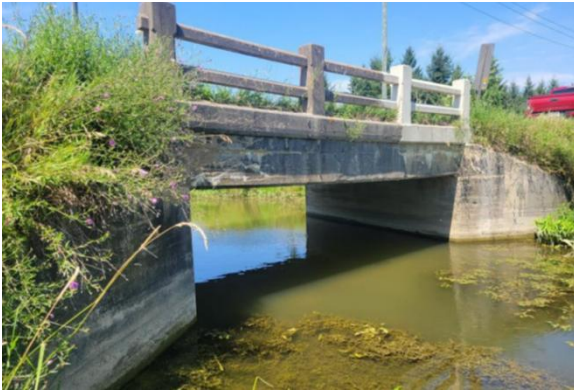
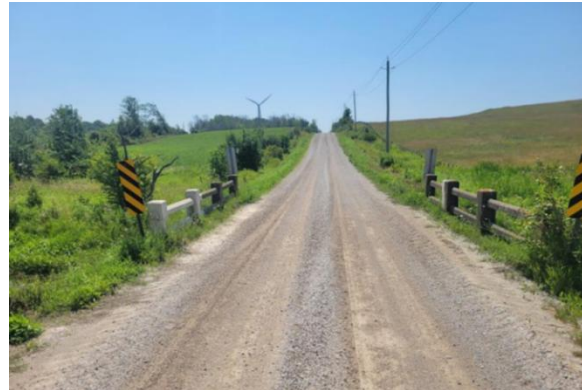
6.2.4. Bridge 2615

Bridge 2615, located on Sideroad J 1 between Concession 6 and Concession 8, was evaluated for the screening criteria to a total score of 74/100, summarized in **Table 6-23**. The replacement, as per the CRV, would cost the Municipality \$427,500.

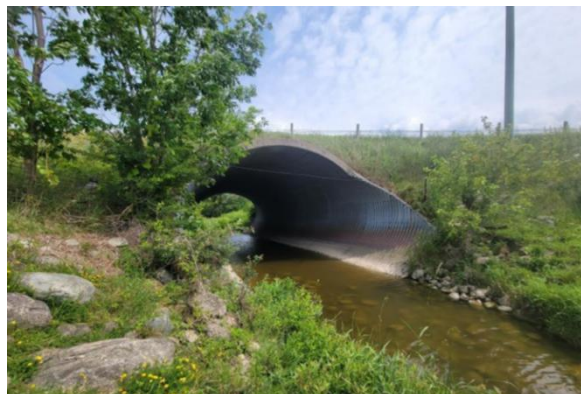
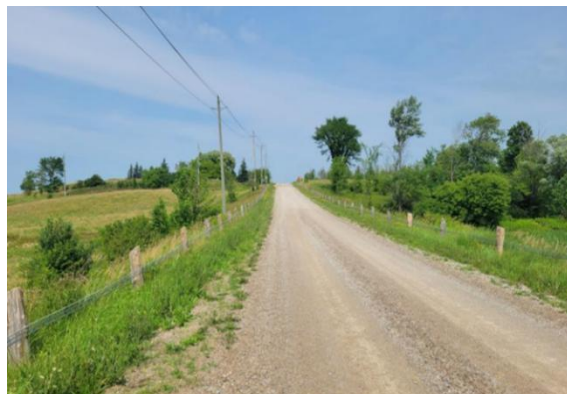
6.2.5. Bridge 2629

Bridge 2629 was evaluated for the screening criteria, with key details summarized in **Table 6-25**, to a total score of 73/100. The replacement, as per the CRV, would cost the Municipality \$895,000.

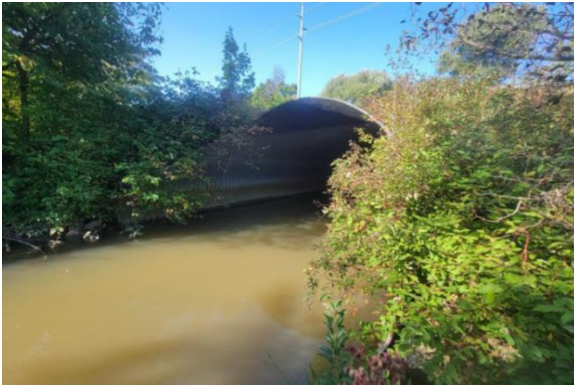
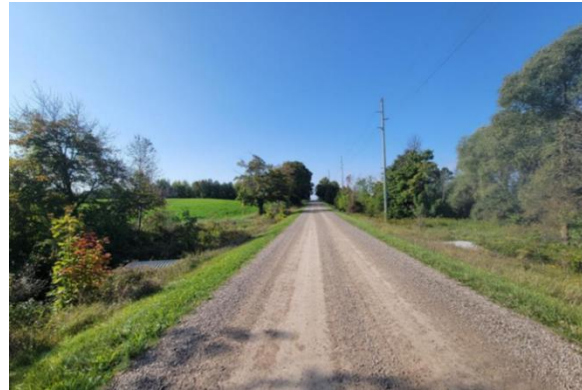
6.2.6. Bridge 2131

Bridge 2131 was evaluated for the screening criteria, with key details summarized in **Table 6-27**, to a total score of 73/100. The replacement, as per the CRV, would cost the Municipality \$783,300.

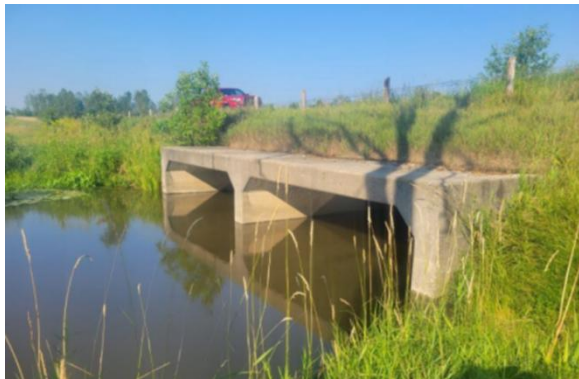
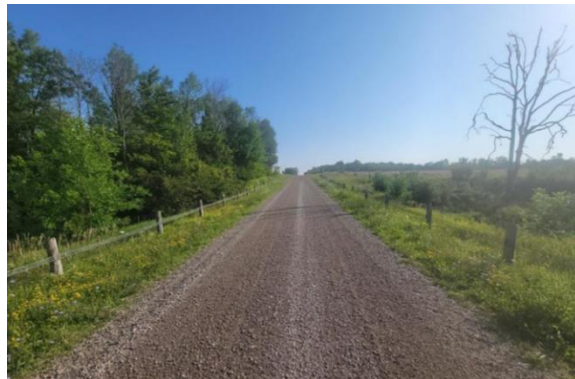
6.2.7. Bridge 2609

Bridge 2609 was evaluated for the screening criteria, with key details summarized in **Table 6-29**, to a total score of 73/100. The replacement, as per the CRV, would cost the Municipality \$1,020,000.

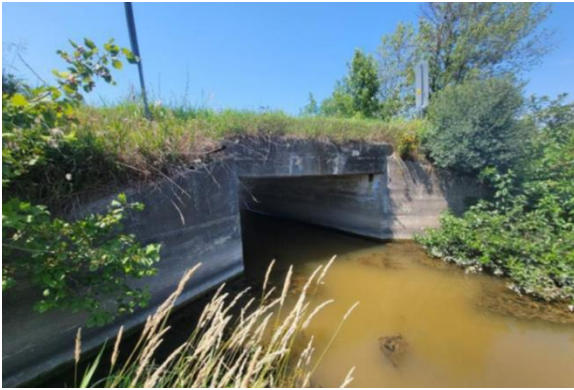
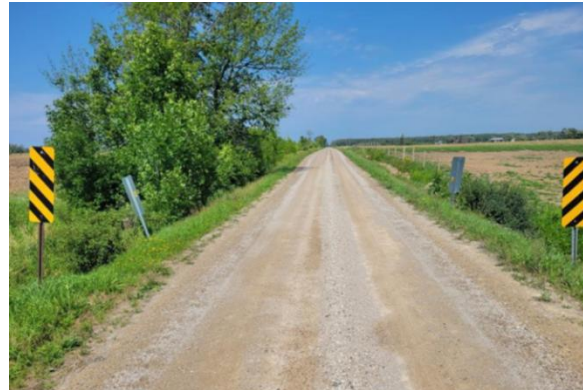
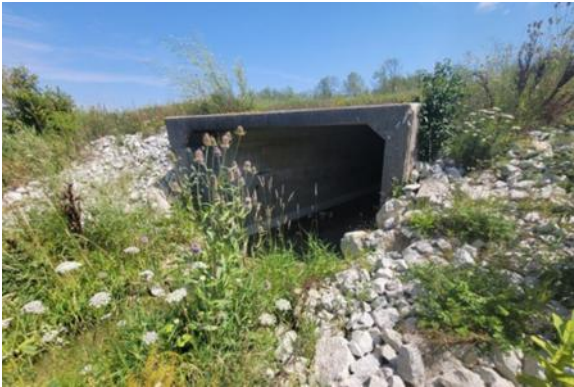
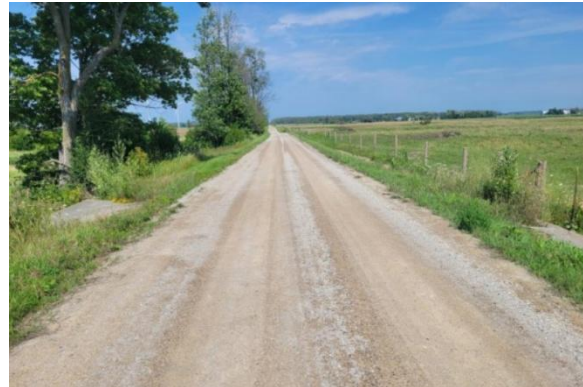
6.2.8. Bridge 2632 & Bridge 2627

Bridges 2632 and 2627 are both located on the stretch of Sideroad J 1 between Concession 10 and Concession 12. This area of road is located between Bruce Road 33 and Highway 21, both paved roads run parallel to Sideroad J 1. Details regarding both Bridge 2632 and 2627 are presented in **Table 6-31** and **Table 6-32** respectively.

As both bridges are <200 meters apart, both can be considered for **retirement** following their deterioration.

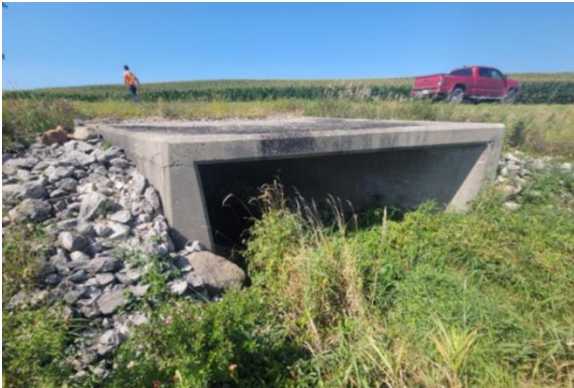
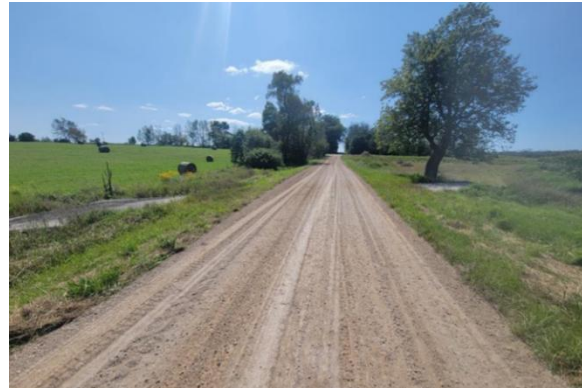
6.2.9. Bridge 2107

Bridge 2107 was evaluated for the screening criteria and surpassed the long-term retirement threshold; key details are summarized in **Table 6-34**. The replacement, as per the CRV, would cost the Municipality \$469,000.

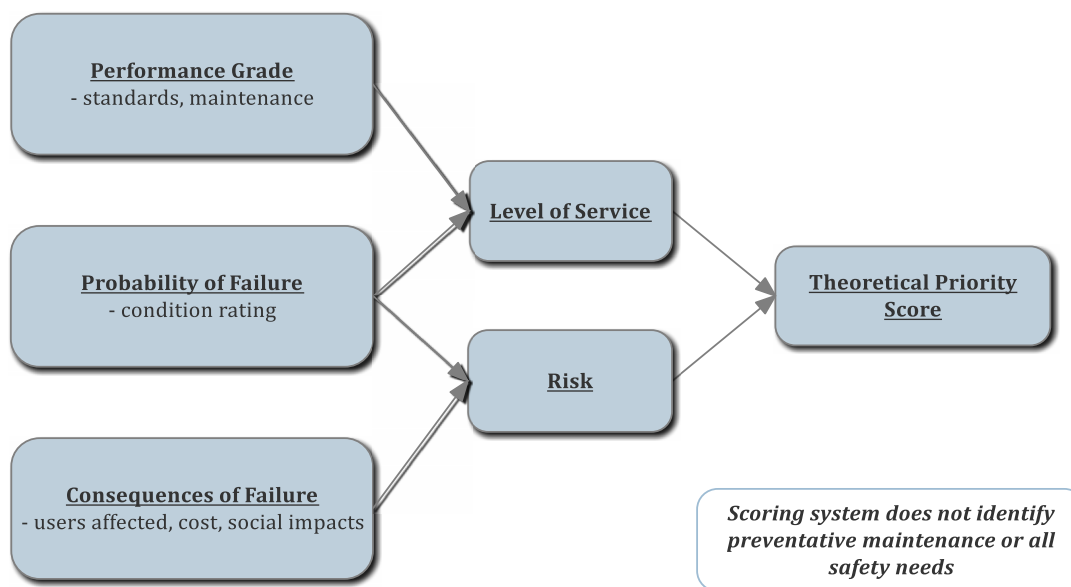
Figure 1
Relationship between Data Collected and Calculated Theoretical Priority Scores

The BCI value calculated as per the OSIM format was used to determine the probability of failure score. Structures with BCI scores below 40 were assigned a score of 5 and structures with a BCI score above 85 were assigned scores of 1. Between those values the score changes by one unit as the BCI score increases by 15 points. Meanwhile, the consequence of failure value has been calculated based on the assumed or supplied traffic volumes on each road section. A score of 1 means it has an average annual daily traffic value of less than 50 and a road with greater than a 1000 vehicles per day would have a score of 5. A table showing how the scores were assigned is provided in Appendix D.
