KINCARDINE SLUDGE SURVEY REPORT 2024

KINCARDINE, ON WASTEWATER LAGOON

Client: Municipality of Kincardine

Date(s) of survey: 26/06/2024

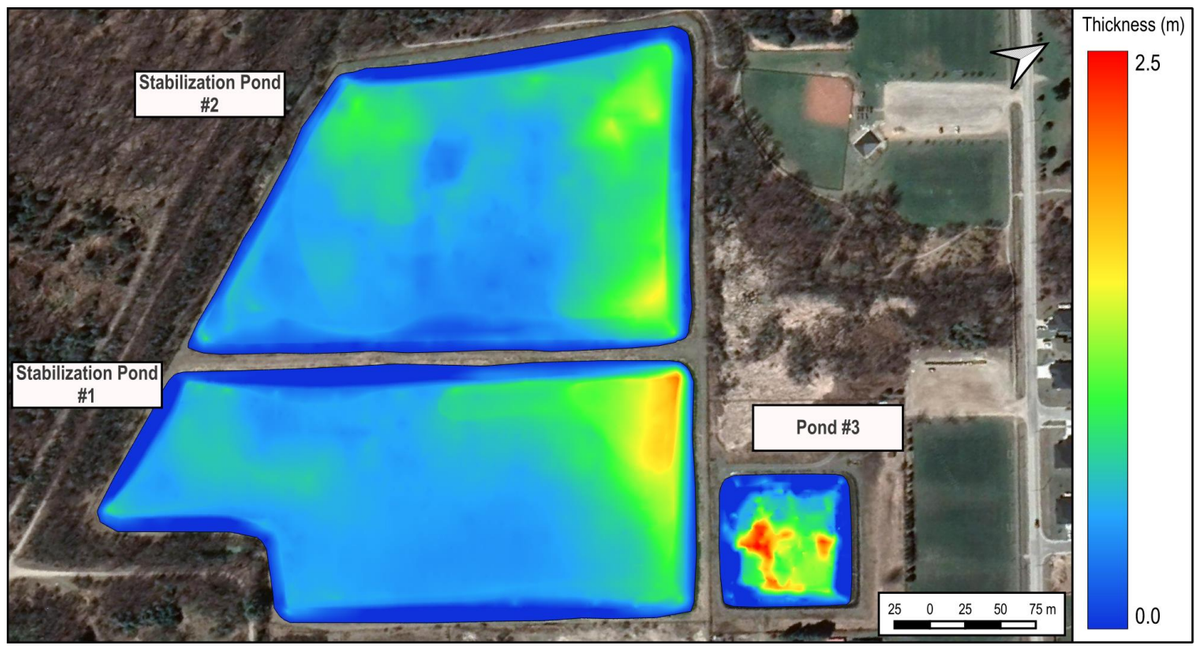
Figure 2 Kincardine, ON Wastewater Lagoon Stabilization Pond #1, Stabilization Pond #2 & Pond #3 sludge blanket thickness

- The Stabilization Ponds #1 & #2 and Pond #3 have 35%, 32% and 24% of the volume occupied by sludge, respectively.
- Pond #3 has four aerators.
- Floating synthetic solids (plastics/rags/non-flushable wipes/debris) and floating sludge crusts were observed in Pond #3.
- Shoreline vegetation in the Stabilization Ponds #1 and & #2 is overgrown (tall grass, trees, brush).
- The Stabilization ponds #1 & #2 have natural bottoms; Pond #3 is HDPE lined.

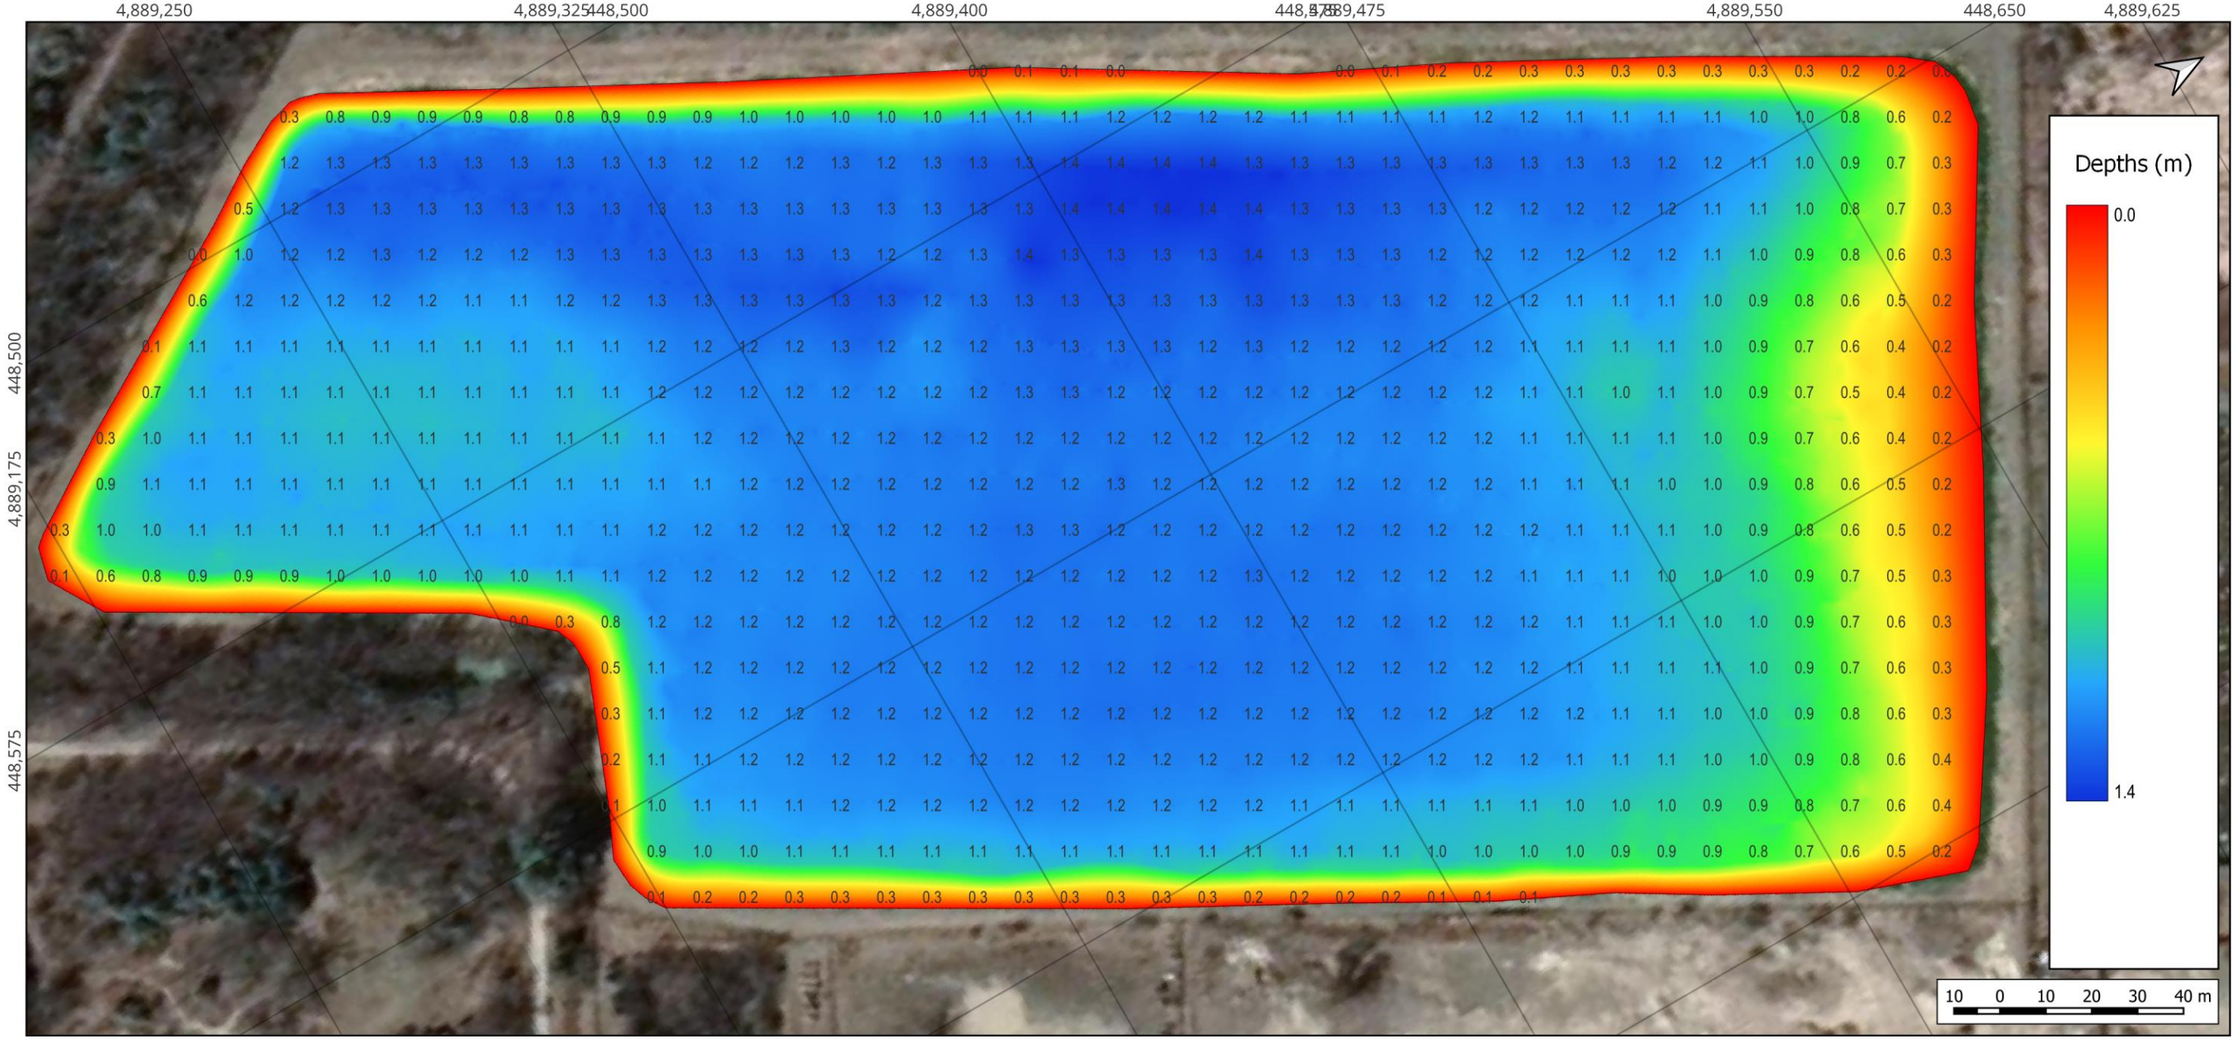
Figure 8 Stabilization Pond #1 top of sludge blanket depths

STABILIZATION POND #1 – TOP OF SLUDGE DEPTHS

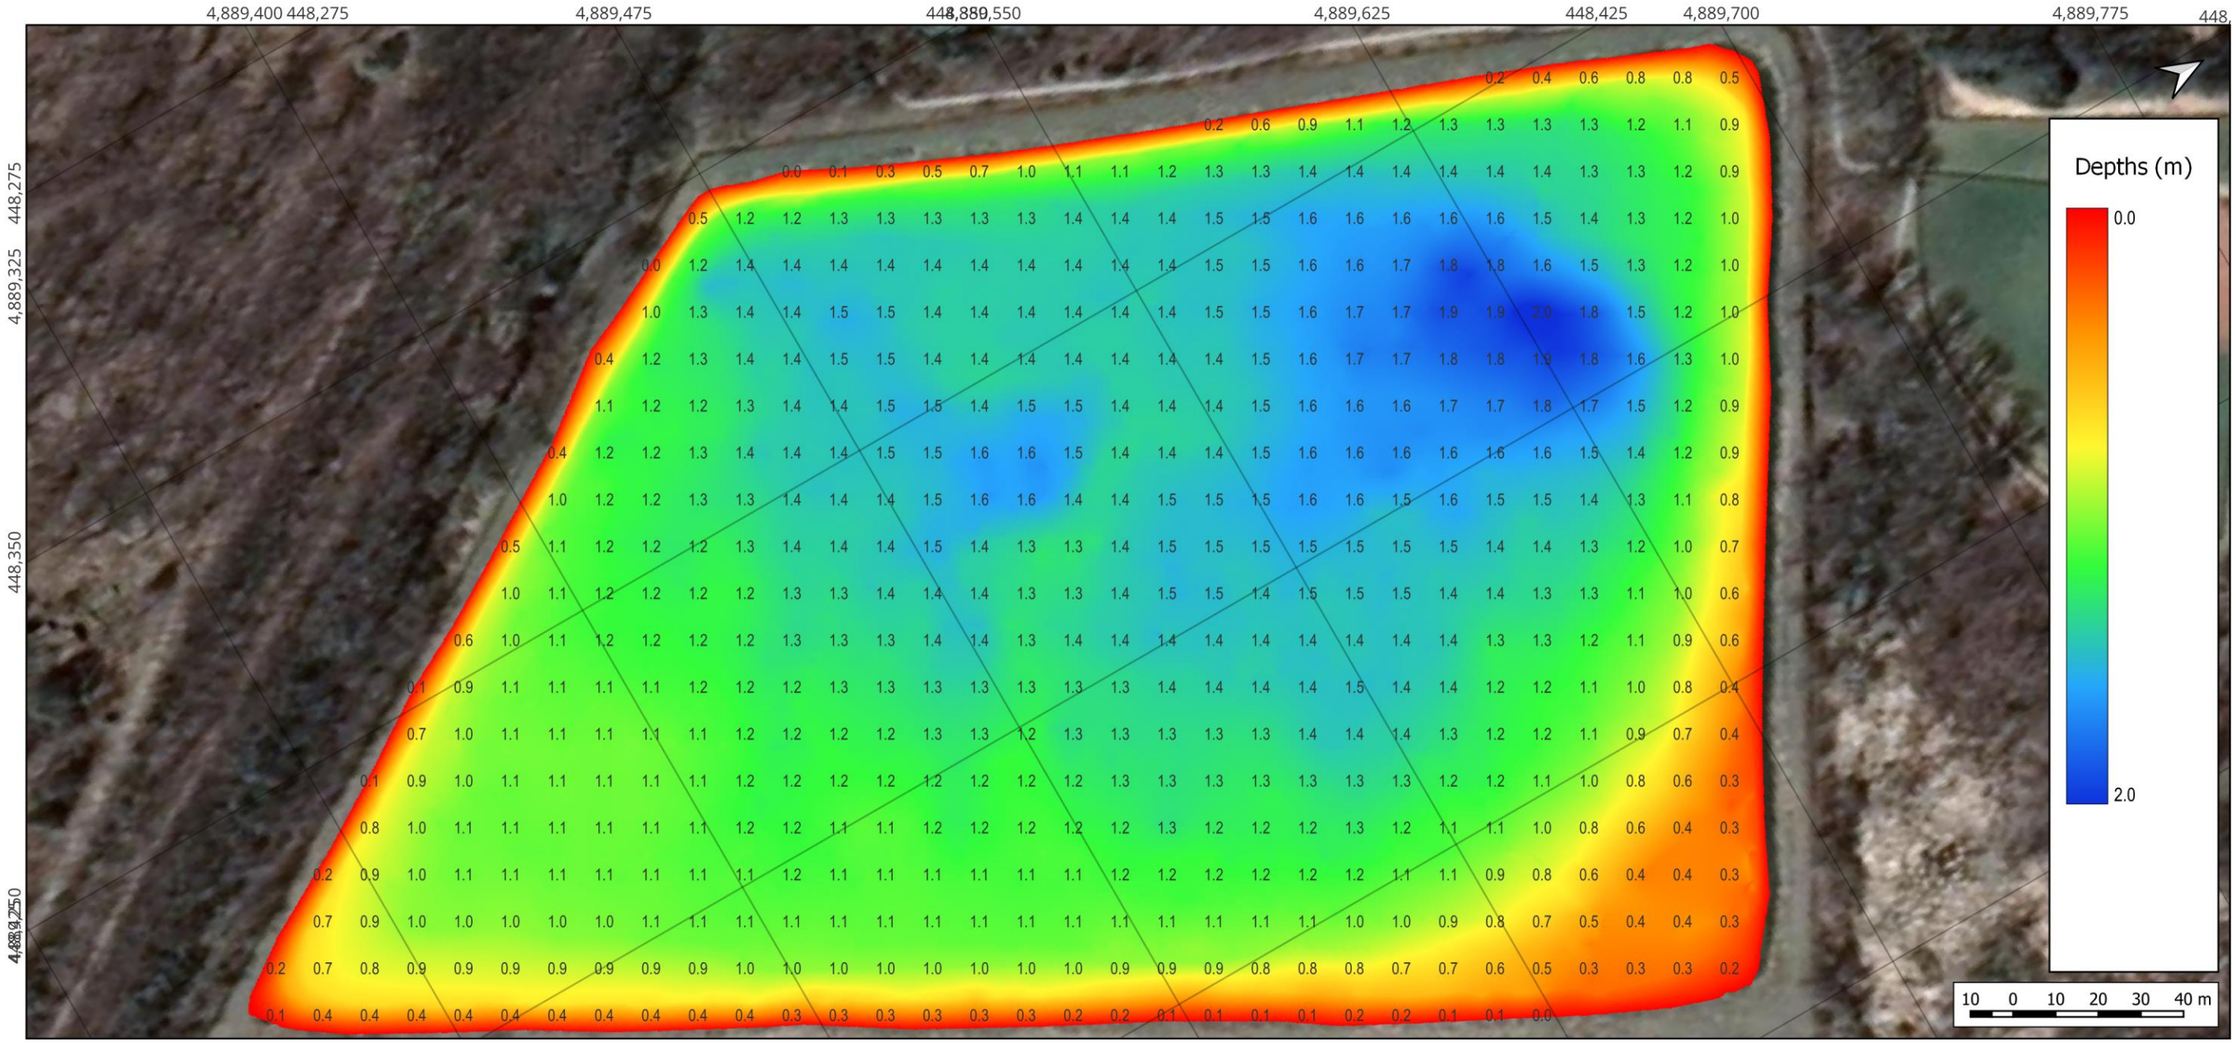
Figure 9 Stabilization Pond #2 top of sludge blanket depths

STABILIZATION POND #2 – TOP OF SLUDGE DEPTHS

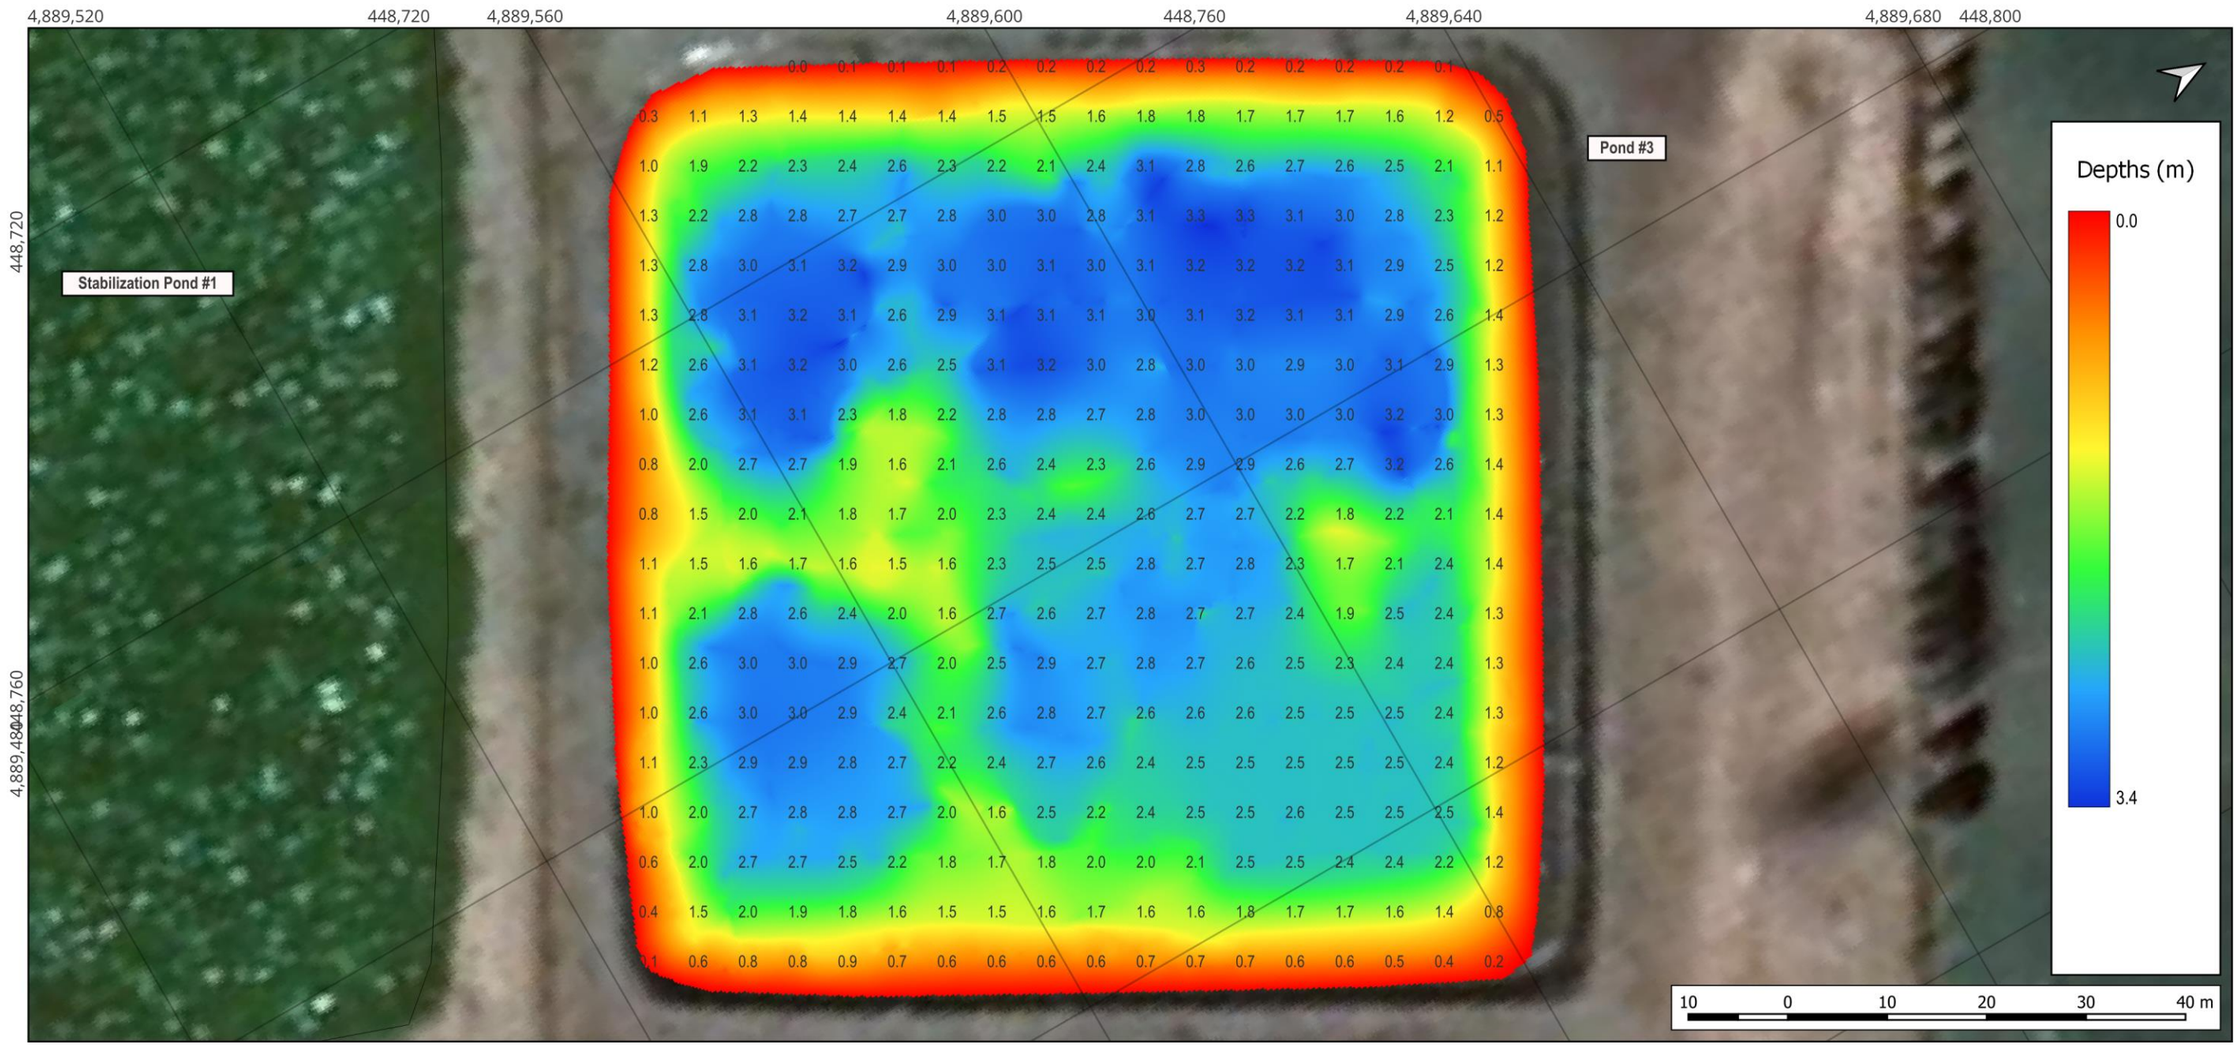
Figure 10 Pond #3 top of sludge blanket depths

POND #3 – TOP OF SLUDGE DEPTHS

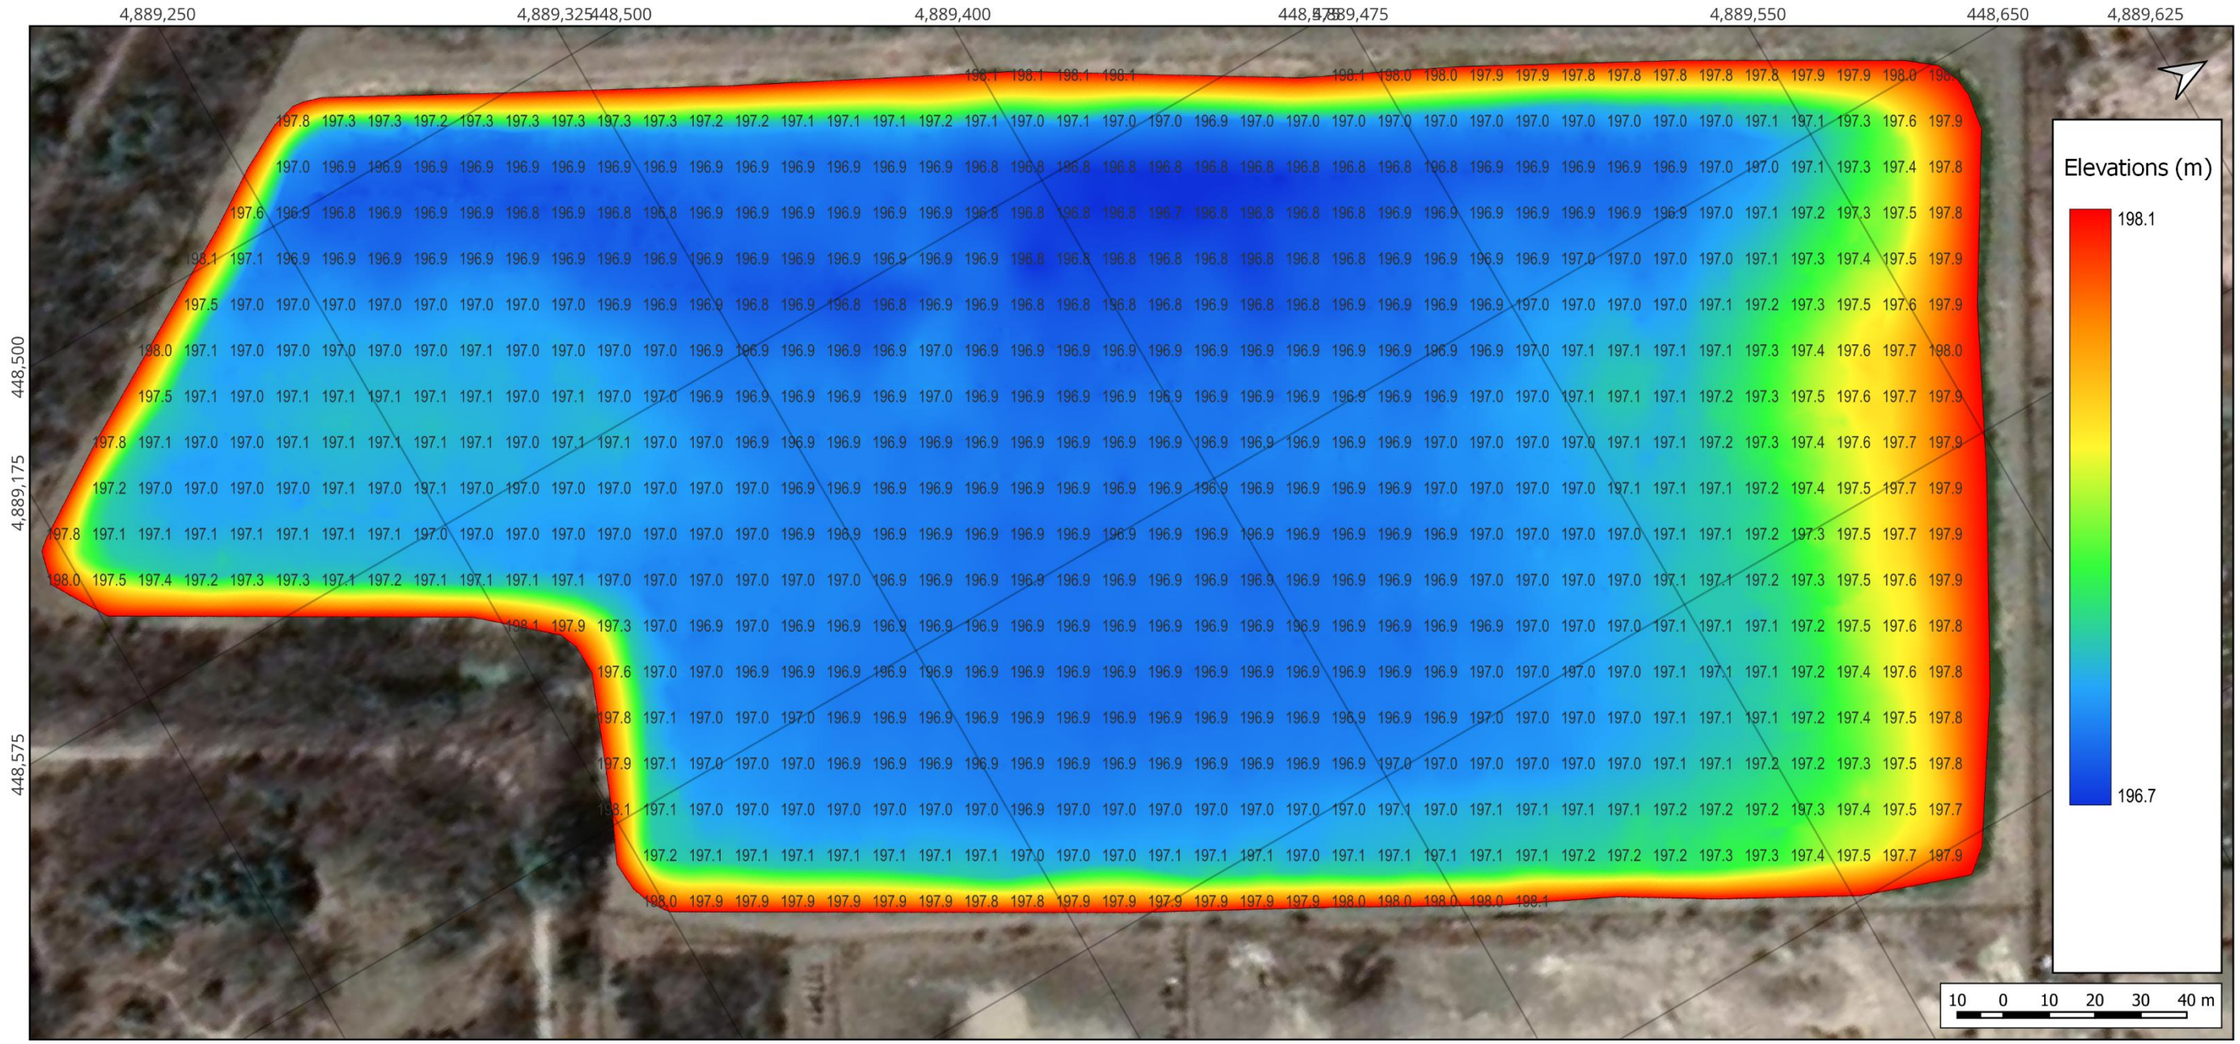
Figure 11 Stabilization Pond #1 top of sludge blanket elevations

STABILIZATION POND #1 – TOP OF SLUDGE ELEVATIONS

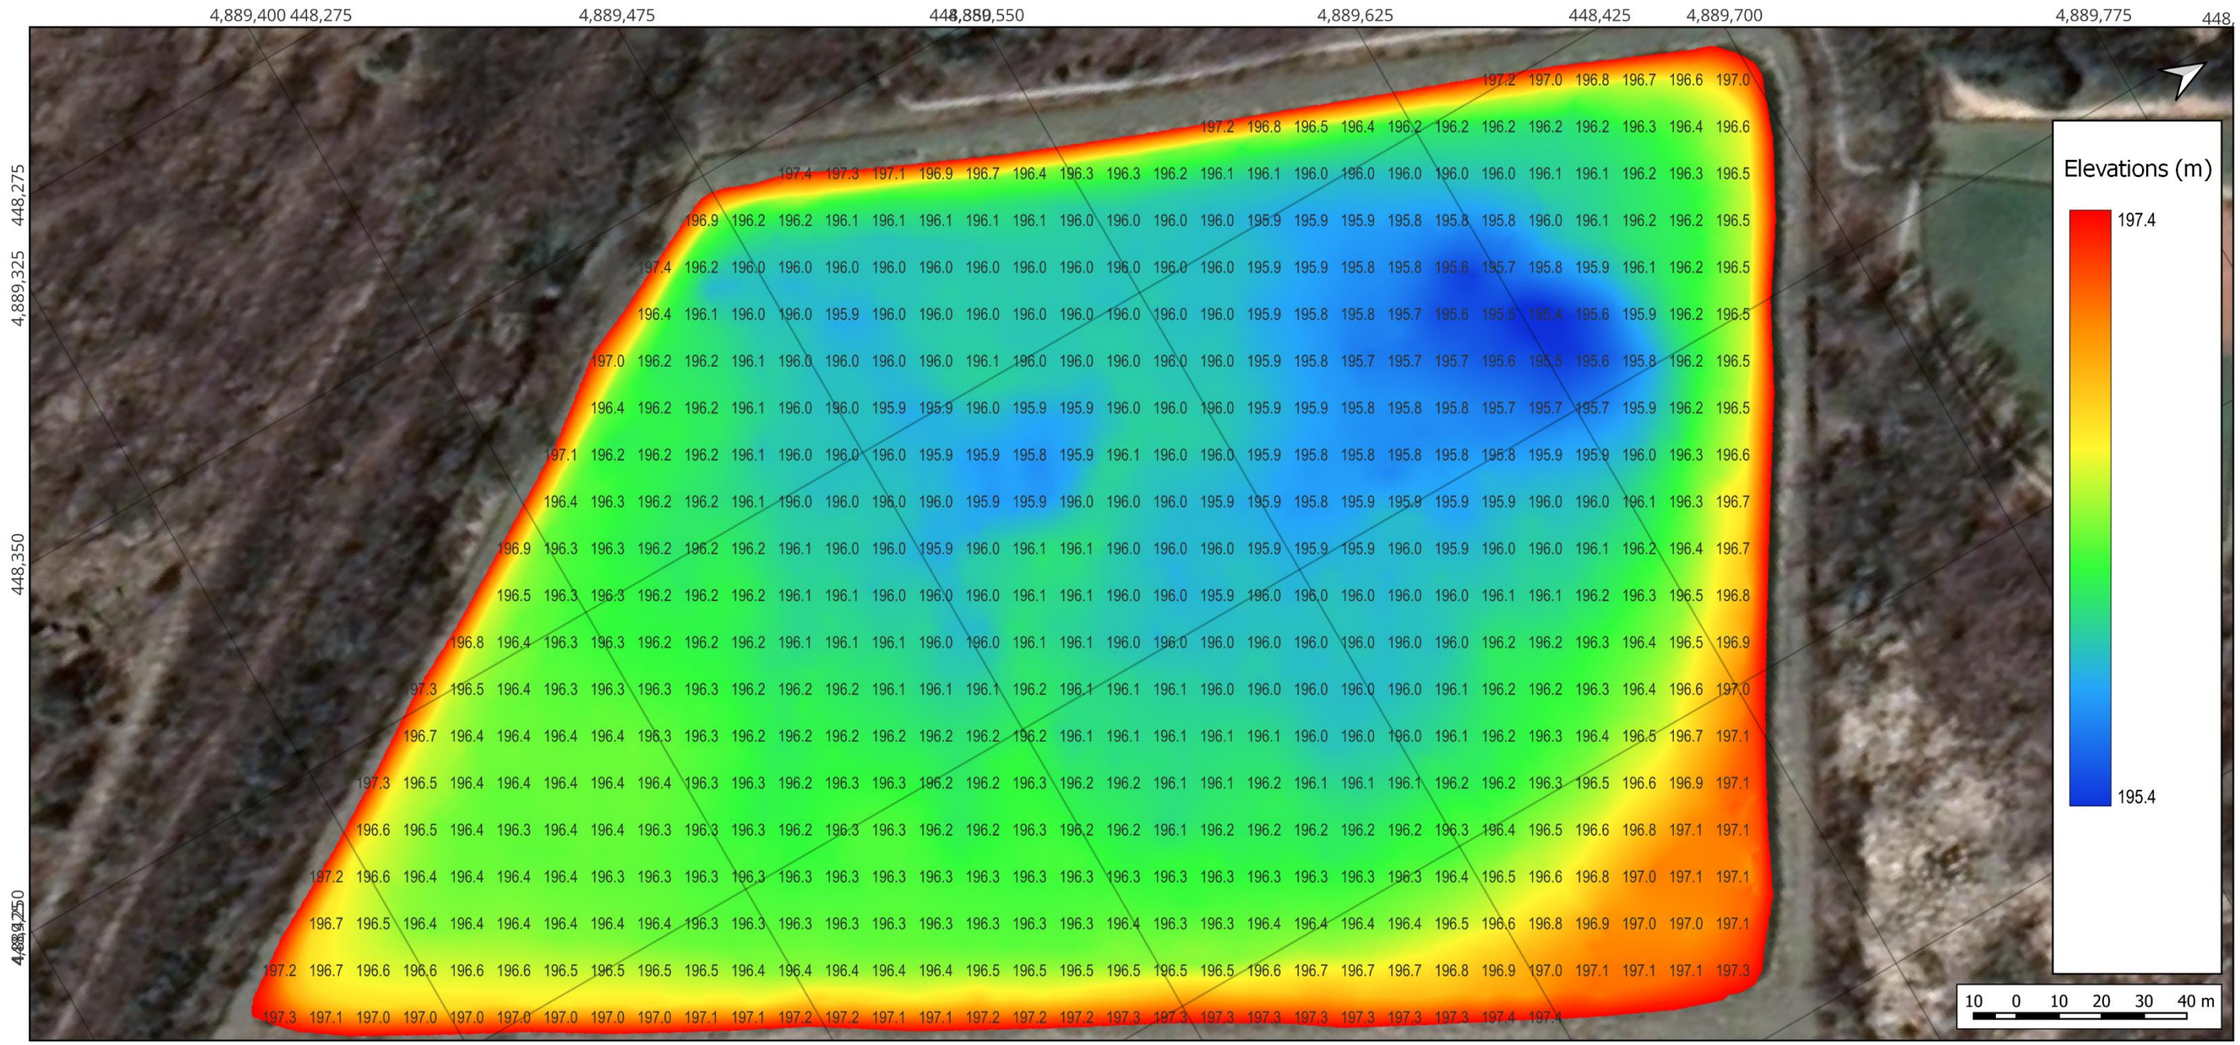
Figure 12 Stabilization Pond #2 top of sludge blanket elevations

STABILIZATION POND #2 – TOP OF SLUDGE ELEVATIONS

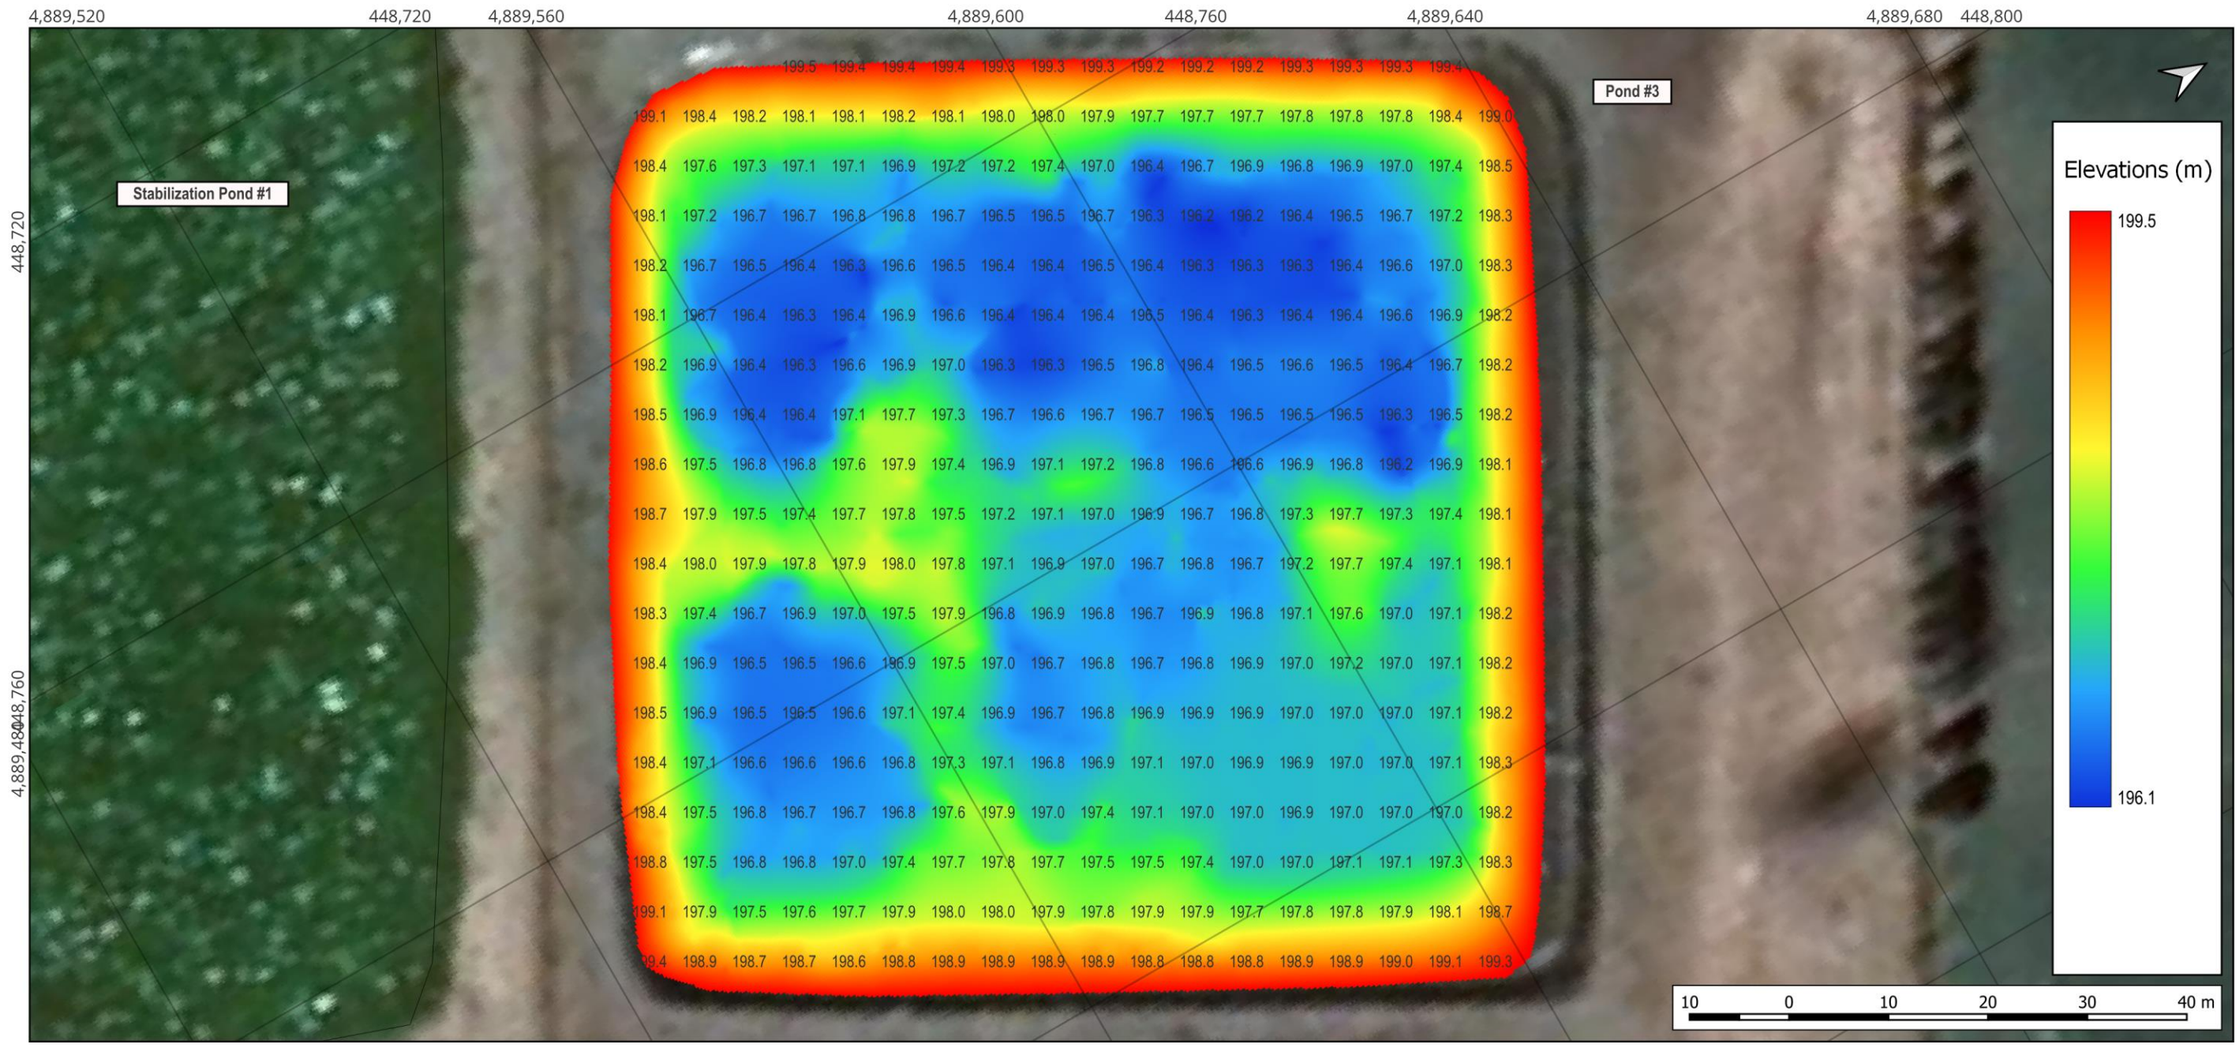
Figure 13 Pond #3 top of sludge blanket elevations

POND #3 – TOP OF SLUDGE ELEVATIONS

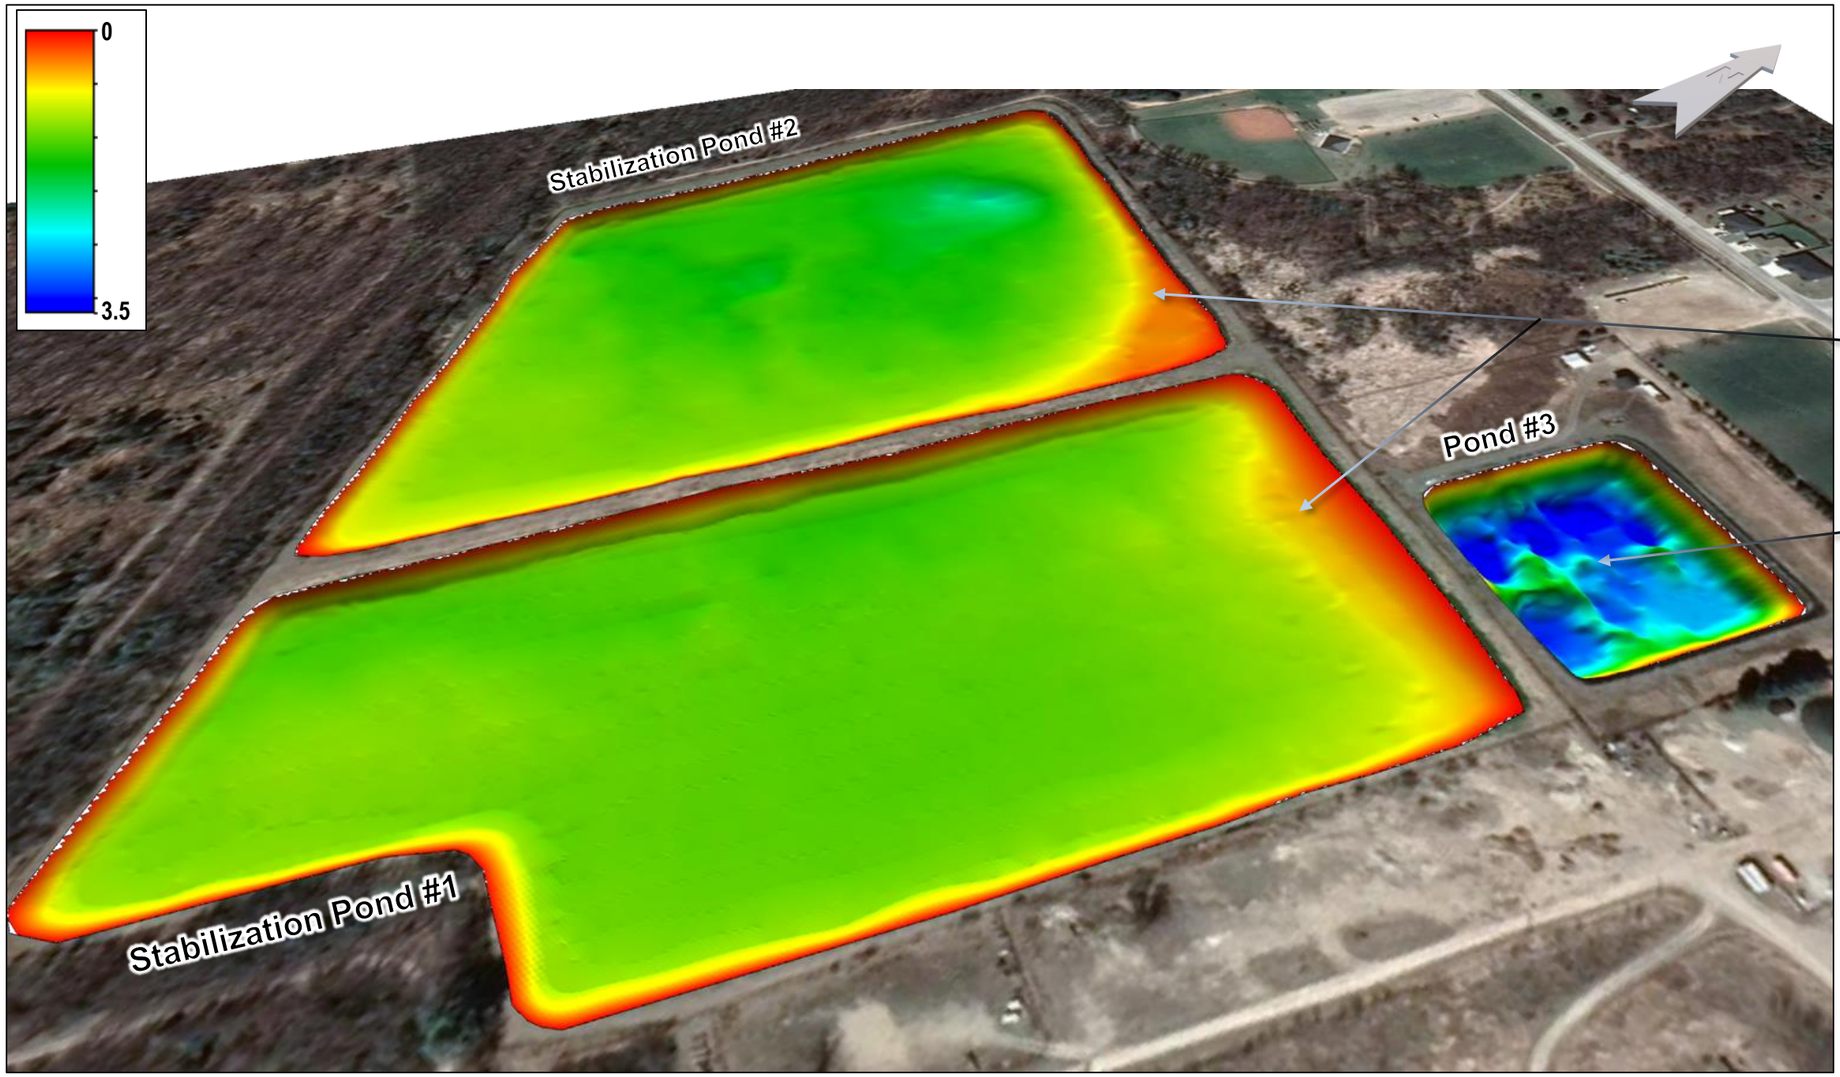
Figure 18 Stabilization Pond #1, Stabilization Pond #2 & Pond #3 top of sludge 3D isometric drawing – southeast to northwest

Top of sludge depths are evenly distributed mainly for the Stabilization ponds #1 and #2, with slightly lower top of the sludge depths in the NE shorelines.

For Pond #3, top of sludge depths varies throughout the bottom, due to the influence of aerators.

The average top of sludge depths for Stabilization Pond #1, Stabilization Pond #2 & Pond #3 are, respectively, 1.02 m, 1.15 m & 2.09 m.

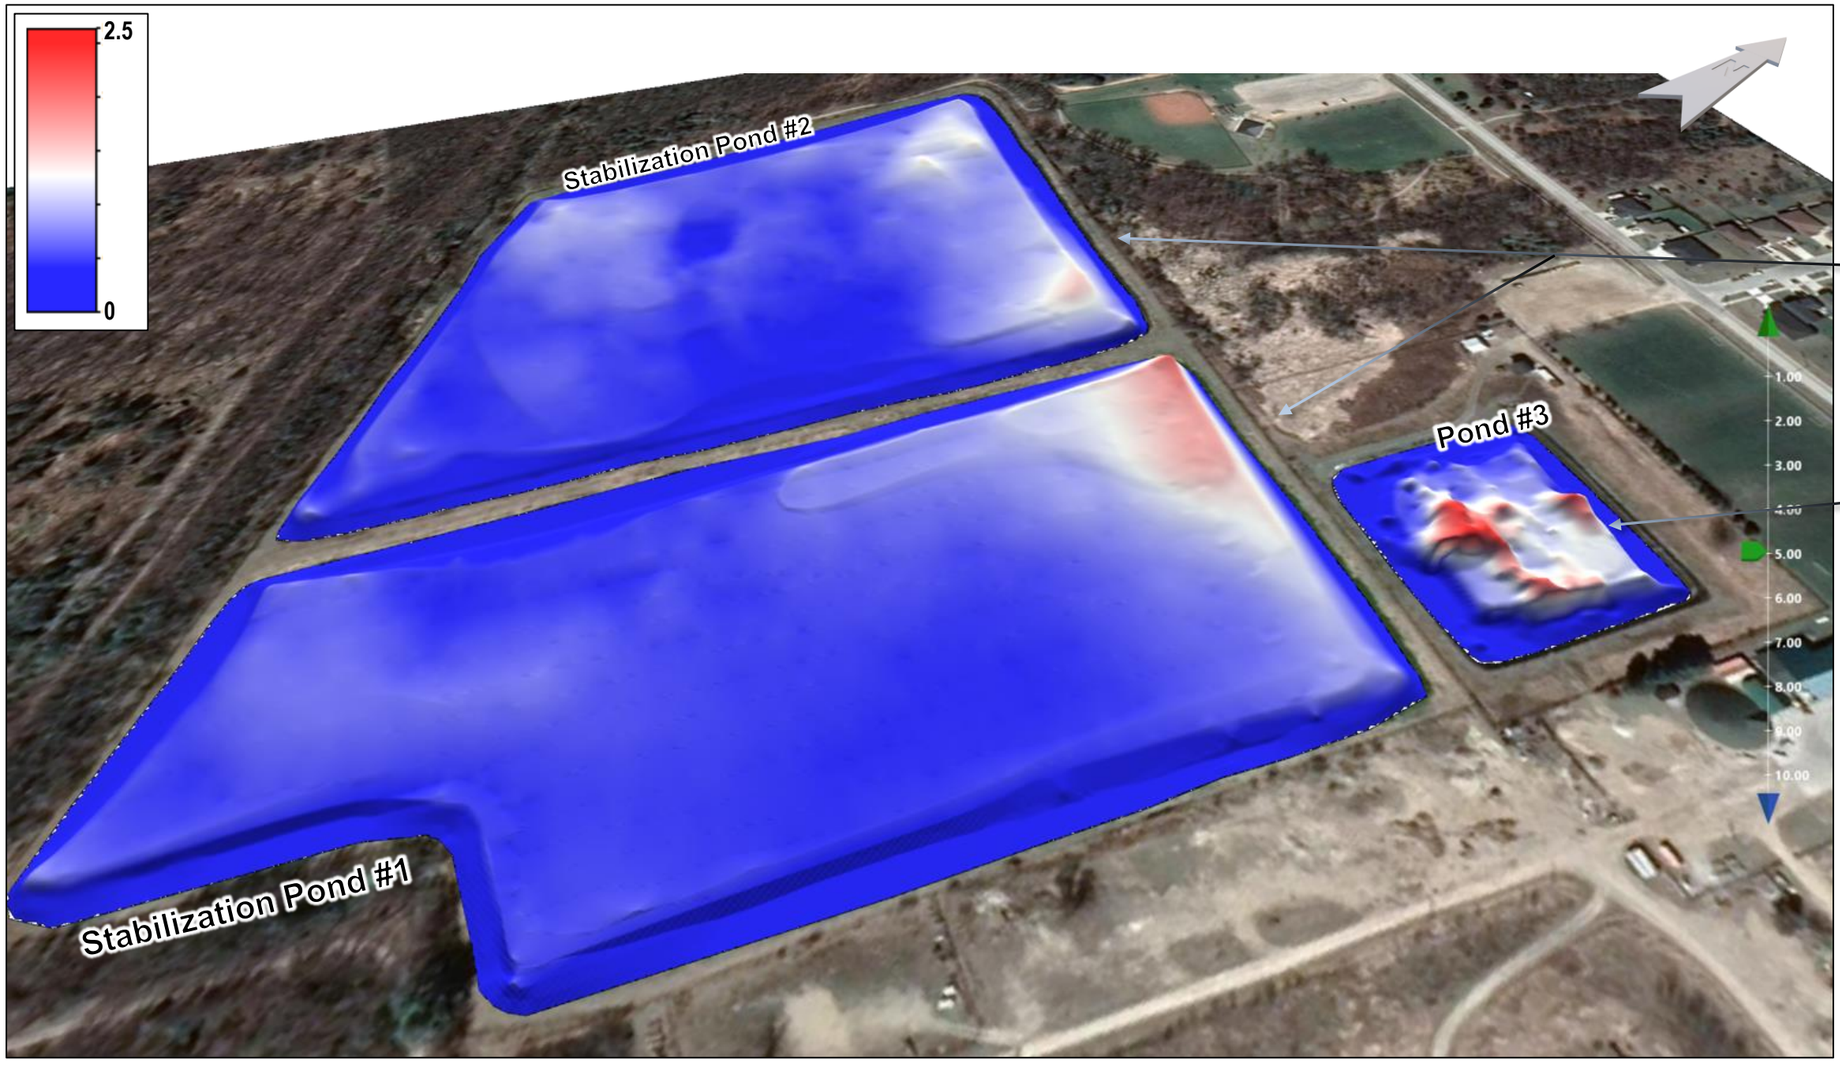
Figure 19 Stabilization Pond #1, Stabilization Pond #2 & Pond #3 top of sludge 3D isometric drawing – southeast to northwest

For the Stabilization ponds #1 & #2, sludge accumulation is overall low, with more sludge build-up along the NW shorelines.

Sludge accumulation in Pond #3 is overall more significant than the previous ponds, and varies throughout the bottom due to the influence of aerators.

The average sludge thickness for Stabilization Pond #1, Stabilization Pond #2 & Pond #3 are, respectively, 0.55 m, 0.55 m & 0.67 m.
