Kincardine Municipal Bridge Master Plan – Campbell Bridge (2121)

Municipality of Kincardine

October 28, 2024
Project No. 2402806

Appendix A OSIM Report for Bridge 2121

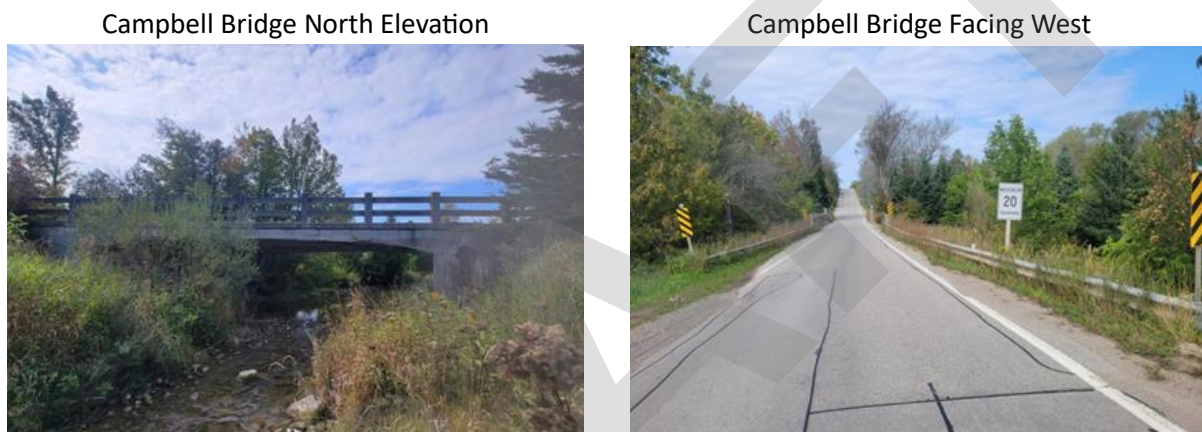
Figure 1-1. Campbell Bridge

This report focuses on the evaluation and strategy for Campbell Bridge, also identified as Bridge 2121, shown **Figure 1-1**.

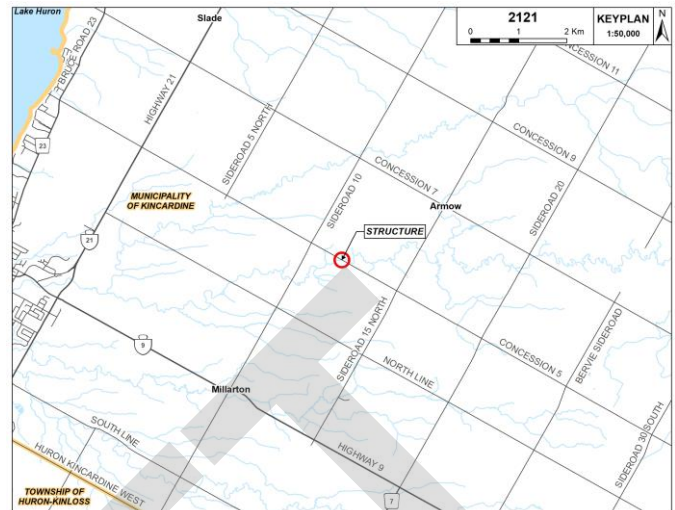
2-North Elevation

Structure Name:	<input type="text" value="Campbell Bridge"/>	BMROSS File #:	<input type="text" value="BR1048"/>	MTO #:	<input type="text"/>
Main Hwy / Road #:	<input type="text"/>	Bridge Condition Index (BCI):	<input type="text" value="19"/>	CRV:	<input type="text" value="\$2,033,000"/>
Road Name:	<input type="text" value="Concession 5"/>	Inspection Date:	<input type="text" value="2023-09-20"/>		
Structure Location:	<input type="text" value="0.7 km East of Sideroad 10, over North Penetangore River"/>		Next Inspection:	<input type="text" value="2025-06-01"/>	
Condition Summary:	<input type="text" value="Replacement recommended"/>	Recommended Timing:	<input type="text" value="1-5 Years"/>		Current Load Limit:
Overall Comments:	<input type="text" value="Rigid frame bridge in poor condition. Replacement and road improvements recommended."/>
