**MUNICIPALITY OF KINCARDINE**

**2024 FACILITY CONDITION ASSESSMENT**

February 14, 2025

**B. M. ROSS AND ASSOCIATES LIMITED**  
Engineers and Planners  
62 North Street  
Goderich, ON N7A 2T4  
Phone: 519-524-2641  
[www.bmross.net](http://www.bmross.net)

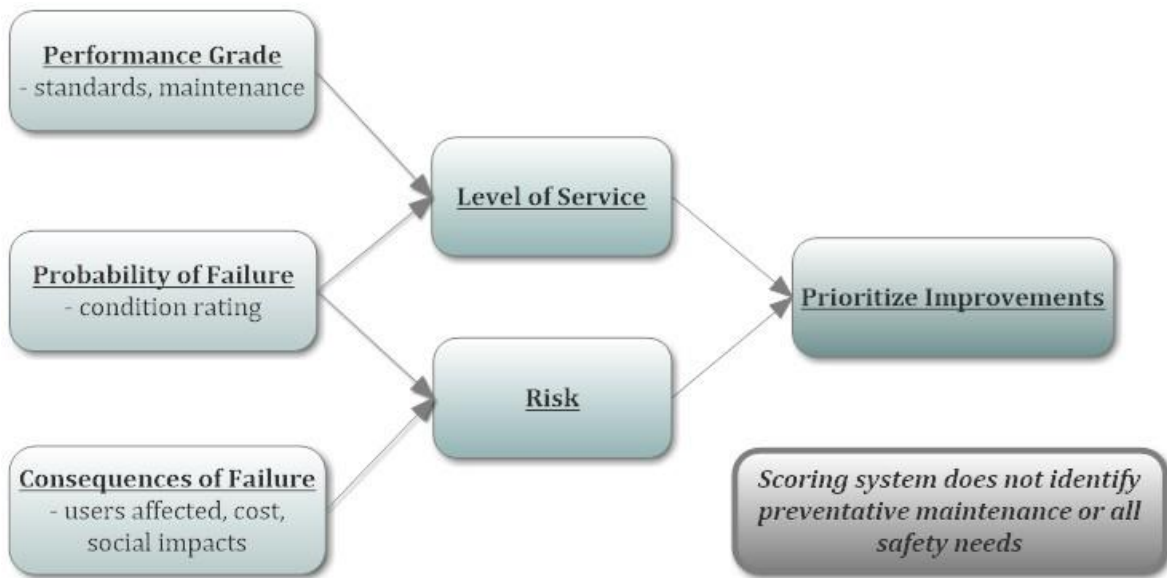
A standardized method is used to calculate a theoretical priority score for each component. When preparing this score, we believe there are generally three key factors that should be taken into consideration: the probability of failure, the consequence of failure and the performance grade. While these factors can include many characteristics of the components, the **probability of failure** factor is generally represented by the condition rating or age of an asset. The **consequence of failure** is a score based on the number of users affected if the asset cannot be used safely or if it is a significant inconvenience to users when the facility cannot be used. The **performance grade** should incorporate a comparison of how appropriately the asset was built versus the appropriate design standard for that particular asset and the relative maintenance requirements of the asset. In a simplified way these components were used as illustrated in Figure 1 to develop a theoretical **priority score** for the improvements.

**Figure 1: Relationship between Data Collected and Calculated Theoretical Priority Scores**

BMROSS has developed a scoring system to help prioritize the improvement needs as per the relationship shown in Figure 1 and, as a starting point, have implemented a suggested scoring and weighting system. The Facility Component Scoring Guide, located in Appendix A, helps to explain, in a tabulated format, how components would be scored. A written description to help illustrate how the scoring system would be applied as follows.

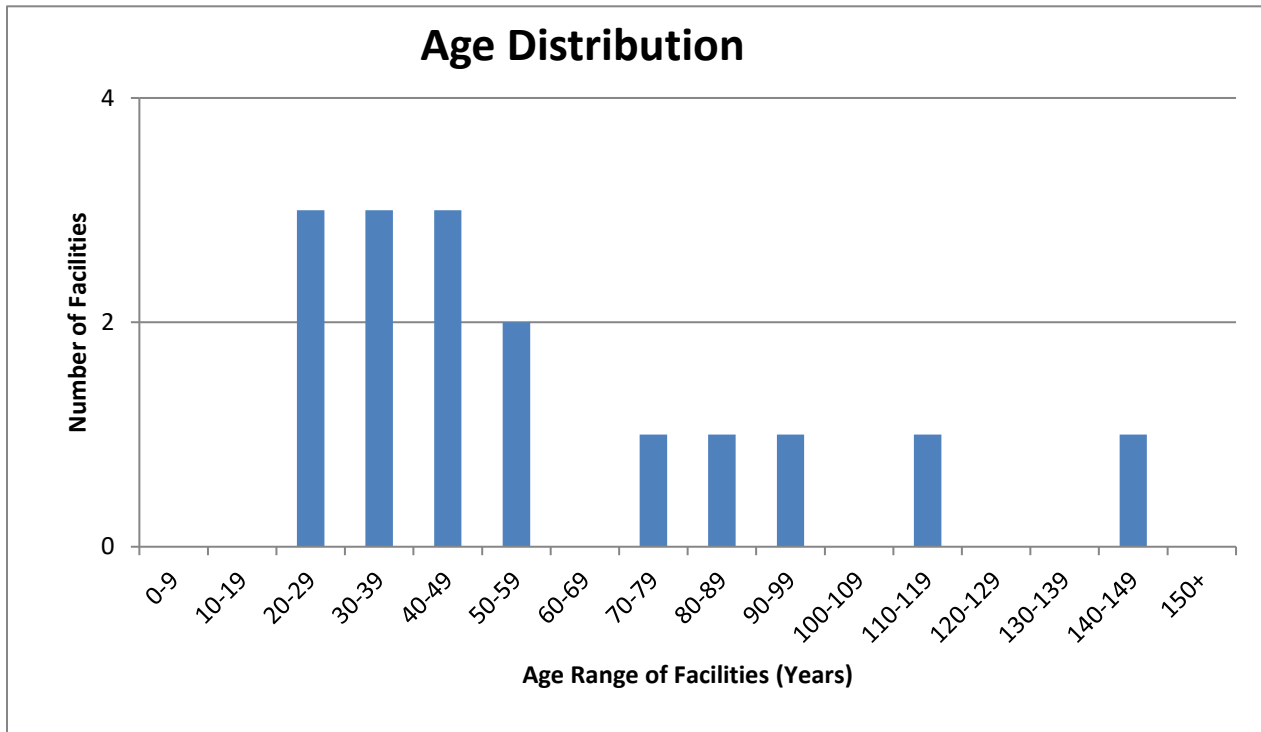
**Figure 4: Age Distribution**

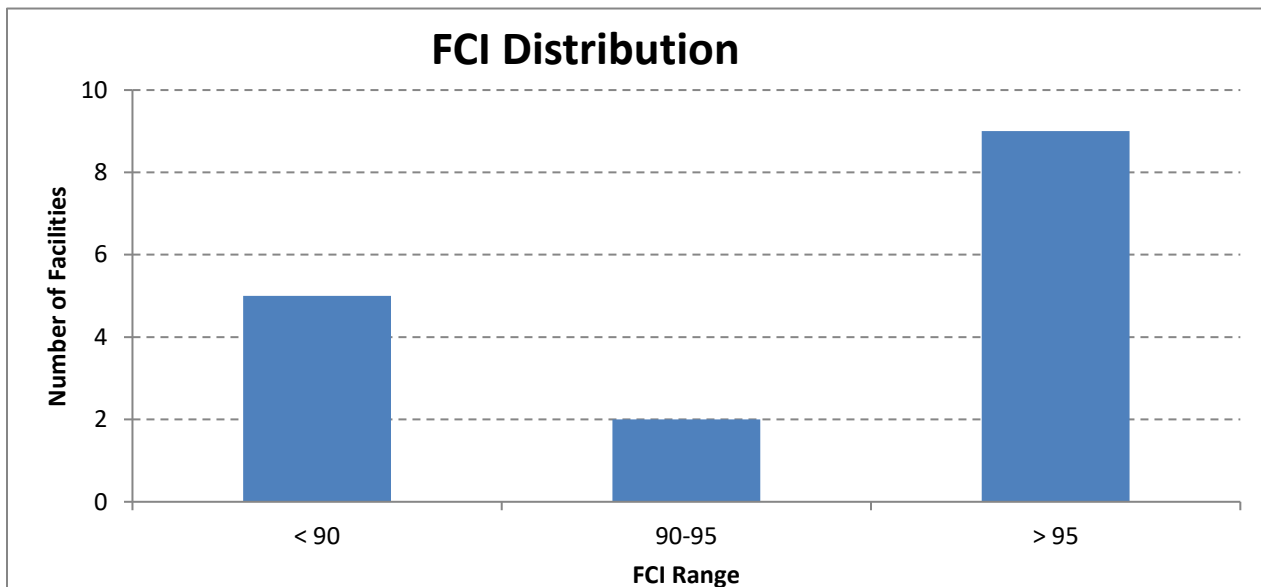
**Figure 5: FCI Distribution**

Figure 5 provides a breakdown of the Facility Condition Index (FCI) range for the Municipality's facilities. The score is developed from the complementary percentage of the facility's current repair costs, projected over the next 10 years, relative to the total facility replacement cost. As indicated in Figure 2, a facility with an FCI greater than 95 would be considered to be in good condition, 90 to 95 in fair condition, 70 to 90 in poor condition and below 70 in critical condition. The weighted average FCI for the facilities inspected within the Municipality is **92.7**.

When looking at the figure it appears that almost all the facilities are in good condition based on the scores. We would like to point out that there were five facilities that scored below 90. Those facilities include: the Tiverton Library, Tiverton Arena, Rotary Park Washrooms, Lawn Bowling Building, and Victoria Park Gazebo.
