Information Report

Title: Boardwalk Design

Report Number: Recreation & Community Programs-2025-01

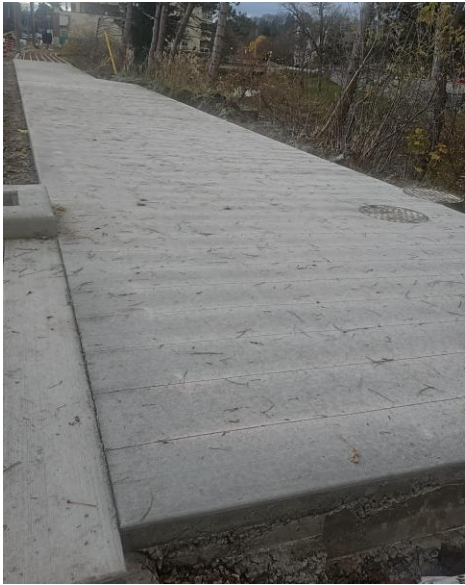
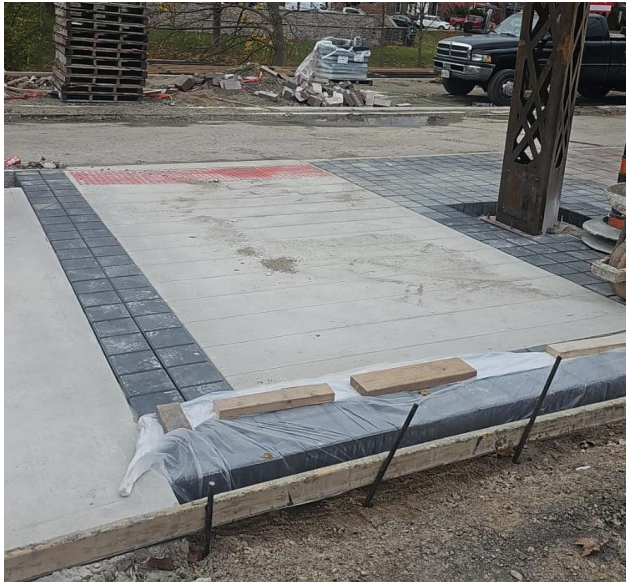
Patterned concrete with a boardwalk pattern was recently installed in Owen Sound's Downtown River District and provides the visual impact of a boardwalk. This work was done by a local contractor. It is a simple alteration from standard sidewalk construction.
